# PRELIMINARY ENGINEERING REPORT

*Shields River Road Planning Project, MT Park 34(1)  
IDIQ Contract No. DTFH7015D00007  
Task Order No. 69056719F000031*

Sept. 27, 2019

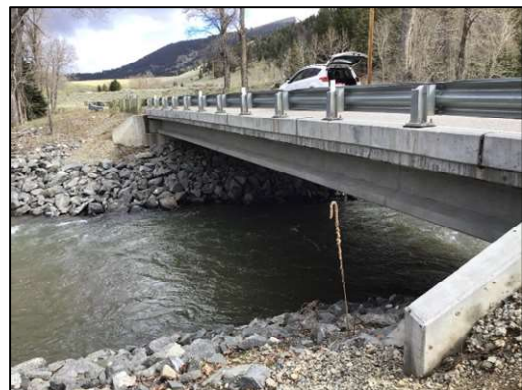
*There are four bridges in the study area. All four bridges are in fair or good condition.*

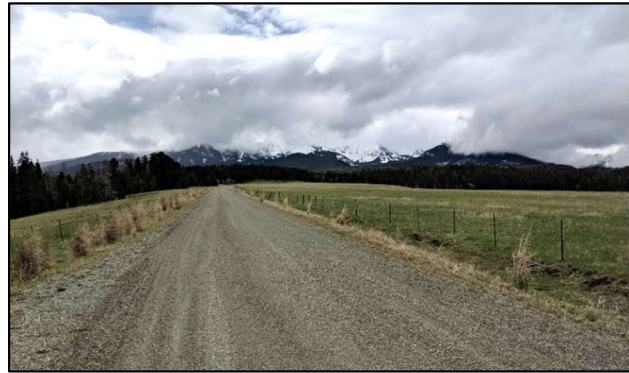
*The first 15.7 miles of Shields River Road are paved; the remaining 3.8 miles are gravel surfaced. The majority of the pavement is in deteriorating condition.*

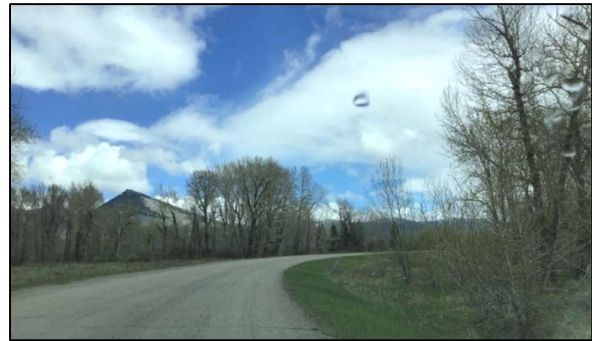
*In some locations, vegetation within the clear zone limits sight distance for drivers. This can hinder the ability of a driver to see oncoming traffic.*

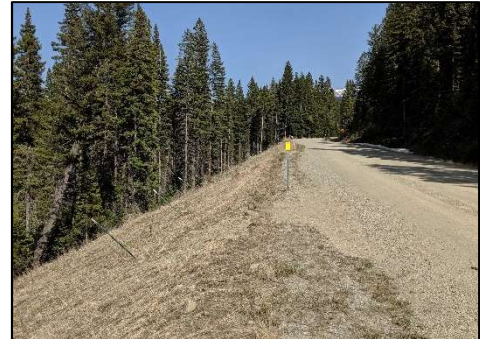
There are many locations along the corridor that have steep side slopes on one or both sides of the roadway. Areas with steep slopes may have an elevated risk of erosion. Slope failures, or landslides, typically occur where a slope is over-steep, where material is not compacted, or where cuts in natural soils encounter groundwater or zones of weak material. These areas of steep slopes are especially important to consider to help minimize the risk of slope failure and avoid the potential for expensive road repairs or road closures. Steep slopes can be stabilized by flattening the slope, adding drainage, or using retaining structures. There were 23 locations identified during the field review as having steep side slopes. Almost half of these steep slope locations (11) are between MP 3.6 and 8.1.

*Areas with steep slopes may have an elevated risk of erosion, slope failures, or landslides. Steep slopes also pose a safety risk to drivers as they are difficult to recover from.*

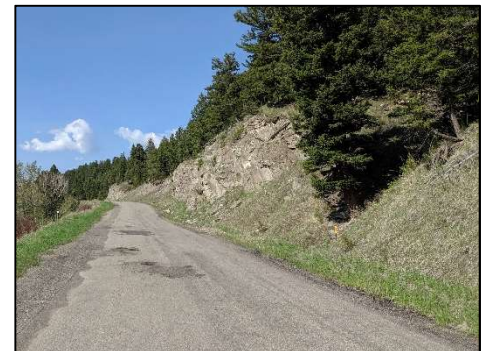
Two landslide areas were documented in the study area during field review. The first is approximately located between MP 6.1 and 6.5. This landslide area was informally rated as medium severity during the field review. The second landslide location is at approximately MP 7.5. This landslide was rated as low severity. Both landslides occurred on the right side of the roadway.

*Two landslide areas are documented along the corridor during field review. Slides caused by stream undercutting are also reportedly present in the study area.*

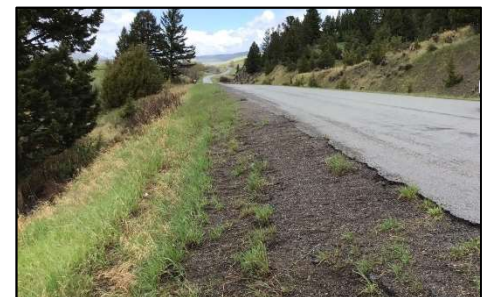
Improper drainage on a roadway can lead to serious erosion issues. When water falls on roads and is not removed promptly, the water seeps into lower layers of the pavement, weakens the soil which can compromise the soil stability and undermine the capacity of the pavement to carry traffic. There were seven locations along the corridor observed to have poor drainage or erosion issues during the field review. In some of these locations there were existing culverts built to divert water from the roadway while others had sections of culverts which had been detached allowing water to pool along the roadside.

*Improper drainage on the roadway can lead to serious erosion issues including deteriorated roadway edges.*

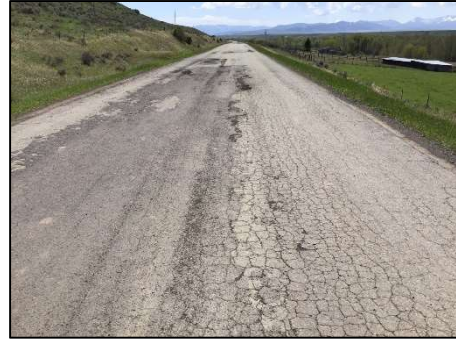
There are locations along the roadway where the subgrade was noted as being deficient during the field review. A weak or deteriorating subgrade is typically characterized by rutting, depressions, or upheaval in the pavement. This distress on the pavement can be caused by a variety of factors including frost heave, lack of compaction, or weak materials. The locations where deficient subgrade was noted occurred between MP 6.2 and 13.5.

*A weak subgrade is characterized by rutting, depressions, or upheaval in pavement. There are several locations along the roadway where the subgrade was noted as being deficient.*

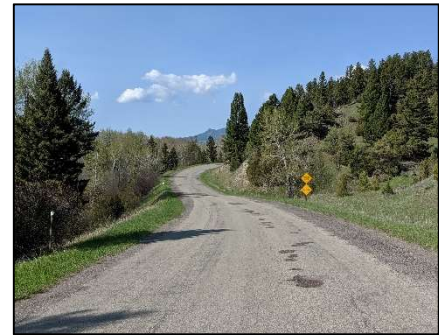
*There are safety concerns at MP 6.0 due to steep side slopes, deteriorating roadway edges, and limited sight distance.*

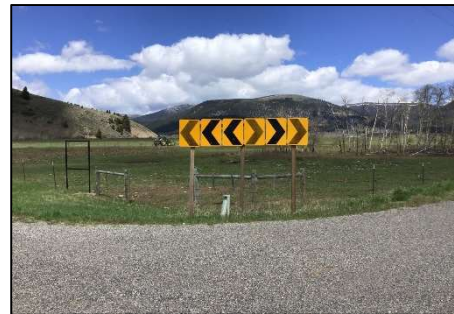
*Most of the existing signage at the intersection of Hill Road/Hamilton Road/Shields River Road has fallen over or is missing.*

- Pavement preservation and general maintenance.
- Enhance signage at MP 14.2 (intersection of Shields River Road/Hill Road/Hamilton Road) to warn drivers of the sharp curve.
- Coordinate with USFS and private residences to construct parking lot at the Shields River Road/Smith Creek Road intersection. The parking lot is estimated to cost approximately \$25,000 not including right-of-way. (Note: this cost is not included in cost estimate)

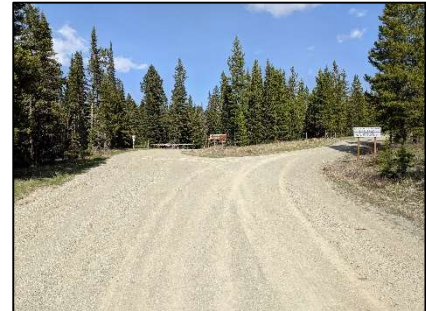
*The gravel surfacing is in good condition. General preservation and maintenance should be completed annually to extend the life of the surface.*
