2020

# Old Yellowstone Trail South Corridor Study

Park County Montana

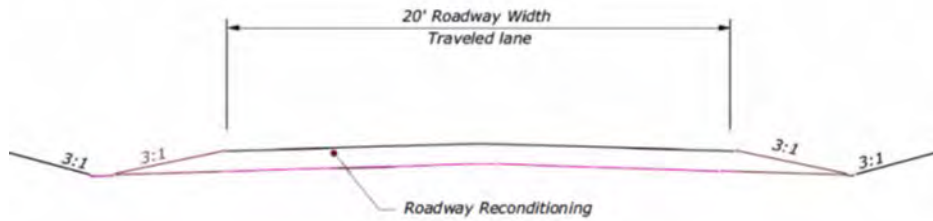
**20-ft Typical Section**

- Improve drainage in problem areas:
  - o Install, replace, repair, or clean culverts where necessary.
  - o Construct drainage ditches. Where drainage ditches are already present, clear them of any debris or overgrowth.

- o Establish crown on roadway
- Apply dust-free surface applications when multi-use trail shares right-of-way. Consider use of a sealant or other treatment that will secure the surface and prevent erosion.

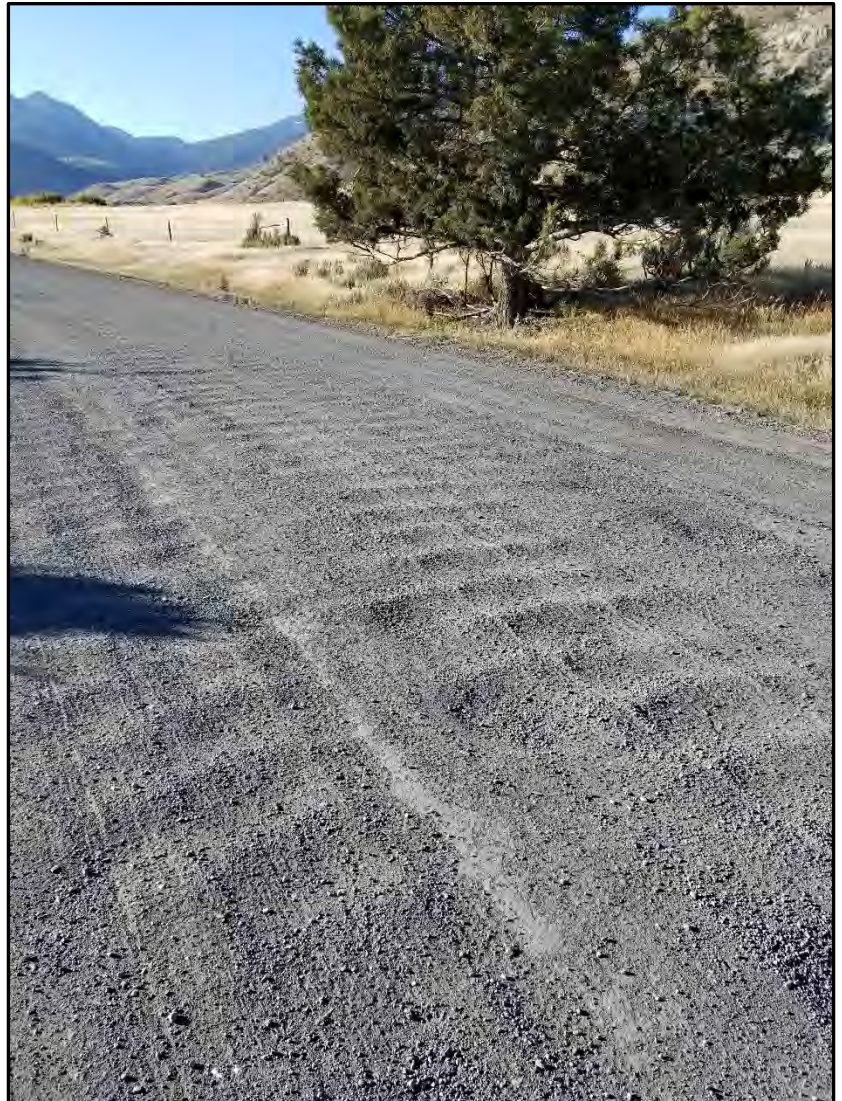
Figure 7 Mile 5.4 looking north.

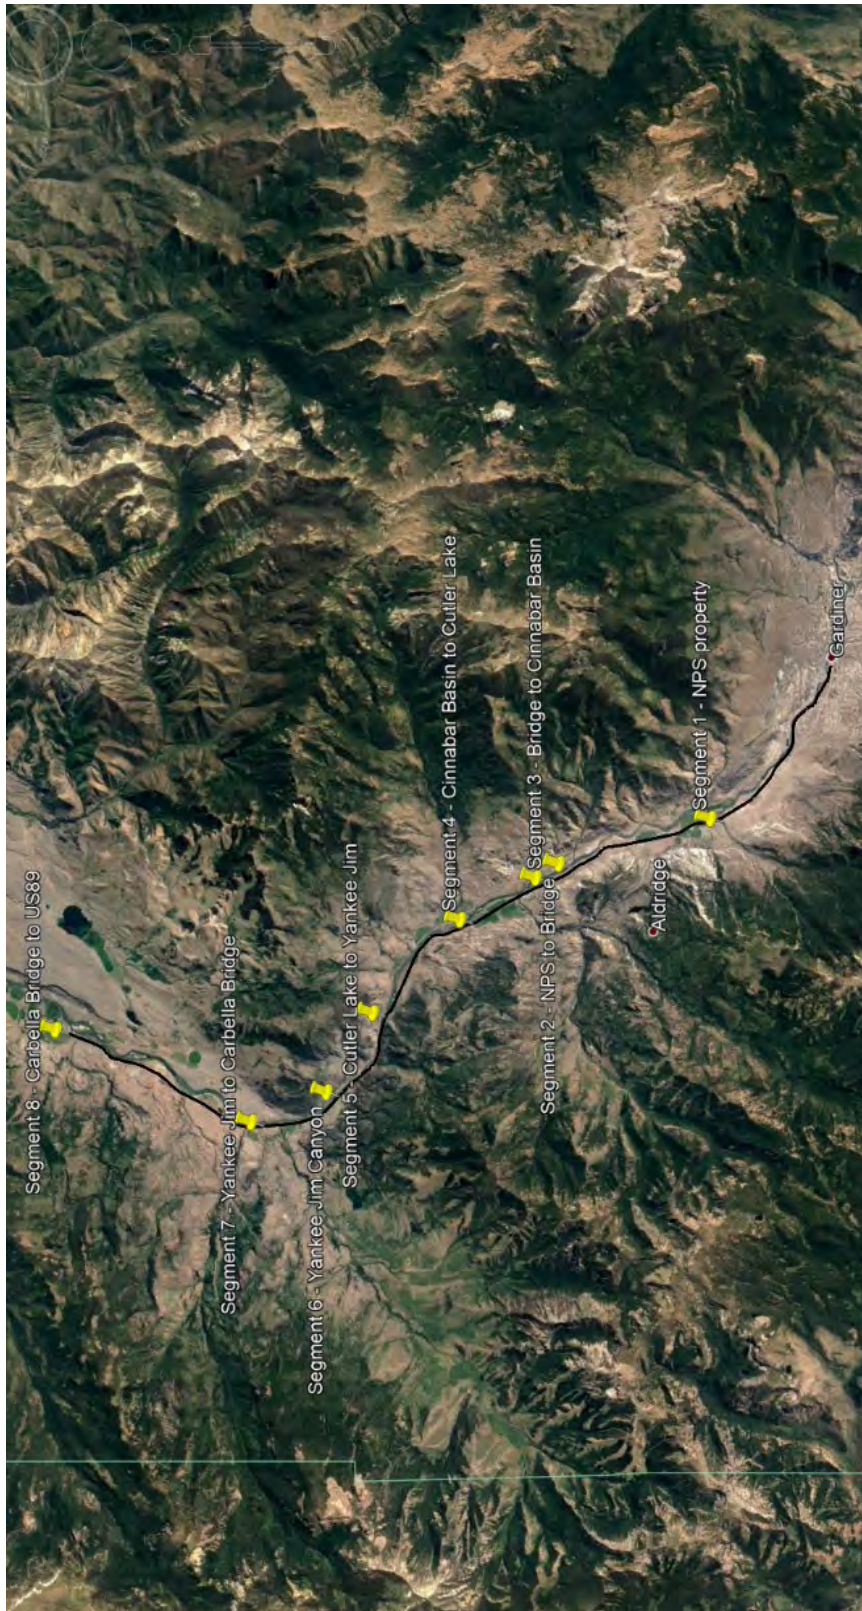
Old Yellowstone Trail South Segment Map

Figure 8 Segment summary for extent of study corridor. Pins mark the end of each segment, with the first segment beginning in Gardiner.

Following is a summary of the segments in the corridor. Based on a segment/node analysis of the corridor, the 22 miles was divided into 8 unequal segments and are identified by milepost. Nodes were established at property lines, intersections, and changes in maintenance category. Descriptions of the corridor start with milepost 0 in Gardiner at the Roosevelt Arch and generally trend north to the intersection with US-89 at milepost 22. Contained within this section is a broad overview of the surface condition, geotechnical assessment, environmental considerations, and safety concerns. Geotechnical information is summarized for each segment based on information contained from a geotechnical assessment. Slopes along the corridor were input into a Federal Highways Administration (FHWA) database named the Unstable Slopes Management Plan (USMP). The USMP provides a risk score based on inputs from the geotechnical expert performing the survey. A detailed report on the rockfall and landslide hazards, how the score is determined, and what the score means is included in this report as Appendix A. A FHWA environmental specialist performed an introductory environmental analysis which is included as Appendix B.

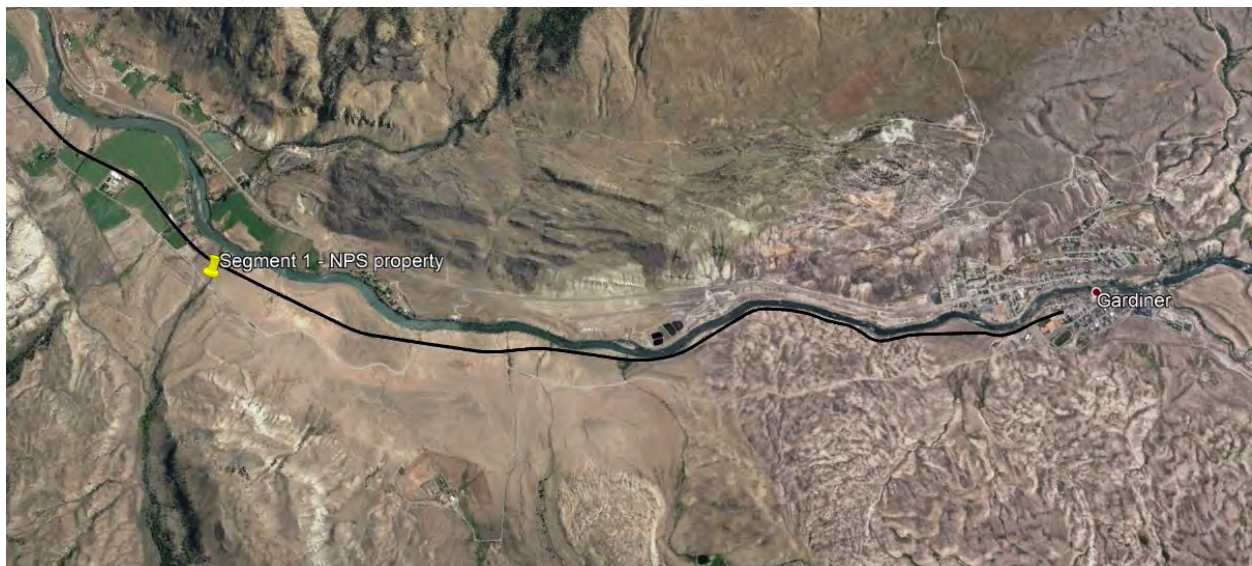
*Figure 9 Segment 1 begins at the Roosevelt Arch and continues to the creek crossing at milepost 4.4, which coincides with the end of NPS property.*

The first 4.4 miles of the corridor reside on National Park Service land, but are outside of the fee area of Yellowstone National Park. Many visitors to this area are likely unaware they are in the park boundary since they have not entered the gate. It is a potential advantage to have the segment of trail adjacent to the population center located on federal land. Future improvements will not require acquisition of easements and the mission of the Park Service is to protect park resources and provide opportunities for recreation and visitor use.

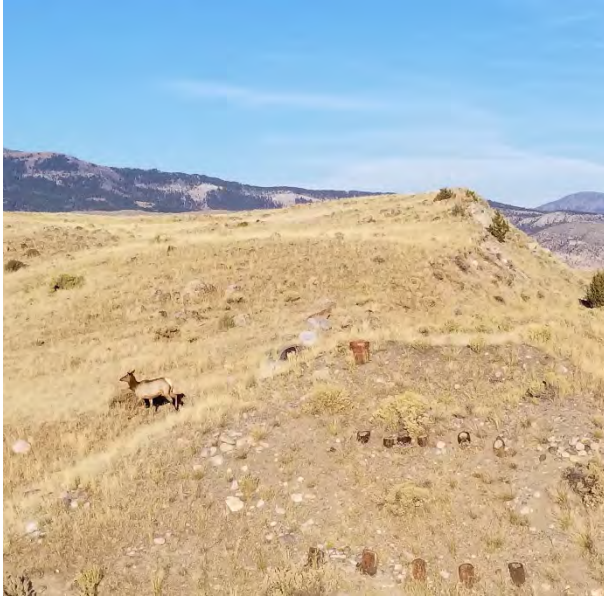
*Figure 4 Mile 0.2. The trail has no clearly distinguished starting point. Much of the trail is devoid of any signage. A young elk is pictured in the left of the picture. It is common to see wildlife at many points along the trail.*

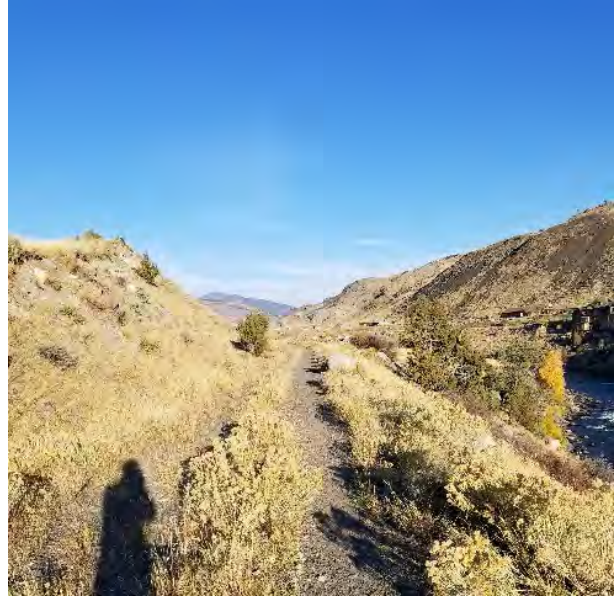
*Figure 5 Mile 0.5. The trail is well established, but foliage is starting to grow over the path.*

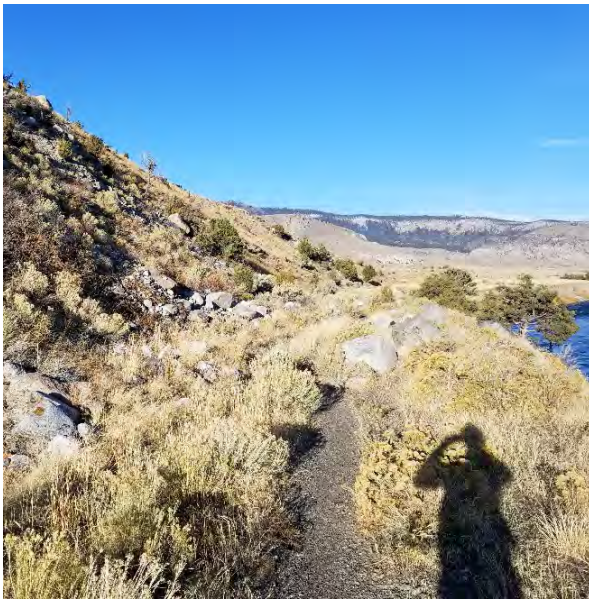
**Geotech:** Much of the trail in this area is cut into ancient earthflows, landslides and glacial deposits. Unstable slopes assessed in this section are either local cut-slopes or eroding fill-slopes along the corridor and not considered unstable due to being a part of the large earth flows. Although there are mostly no catchment ditches along most of this section, the trail width is wide enough to provide some catchment for rockfall along the old railroad grade. Potential avenues for mitigating rockfall in this section could be selective rock scaling, lessening cut slope angles, improving the catchment ditch, or various trail-side barrier types. Erosion closer to the riverbank is also leading to destabilization of the slope below the old railroad grade.

*Figure 10 Mile 0.75. Falling rocks have blocked sections of the trail.*

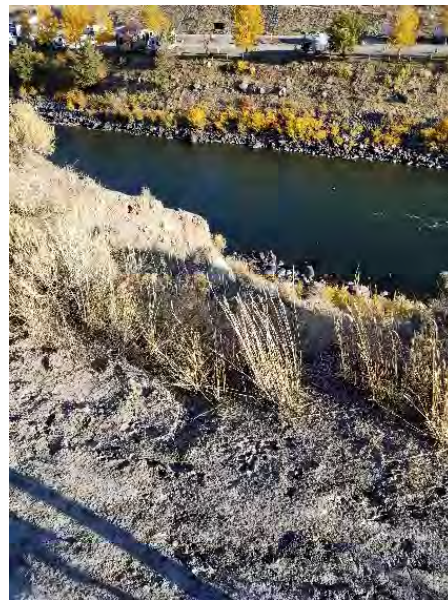
*Figure 7 Mile 0.75. Erosion on the fill side above the Yellowstone River.*

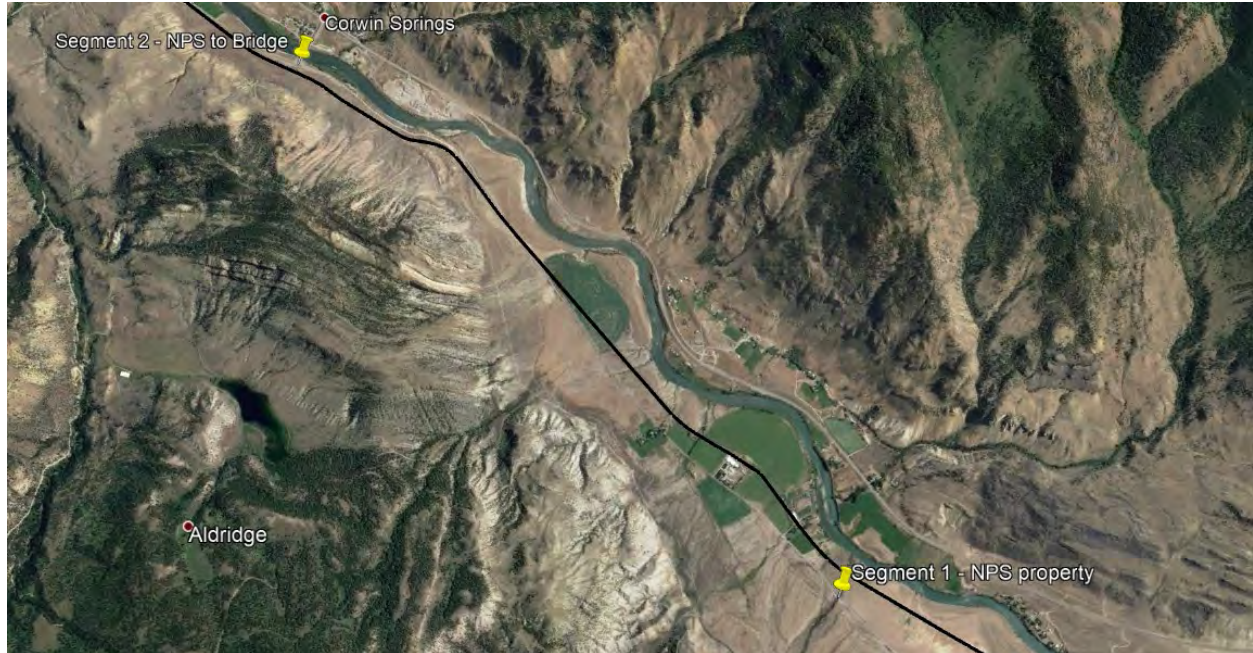
Figure 10 Segment 2 extends from NPS property line to Corwin Springs Bridge.

National Park Service property abuts a small section of Forest Service land which covers only a short distance before the former rail corridor continues on private property. Along this segment and the next, significant sections of private property reside under the old rail alignment. There has been no discussion with property owners about the possibility of utilizing this historic alignment. In the next phase of development, the NEPA process will evaluate the possibility of easements or land swaps. The likelihood certainly exists that bicycles, hikers and other users of the corridor will share right of way with the road if property owners are not supportive of using the alignment. Final alignment will depend on factors of safety, environment and ownership.

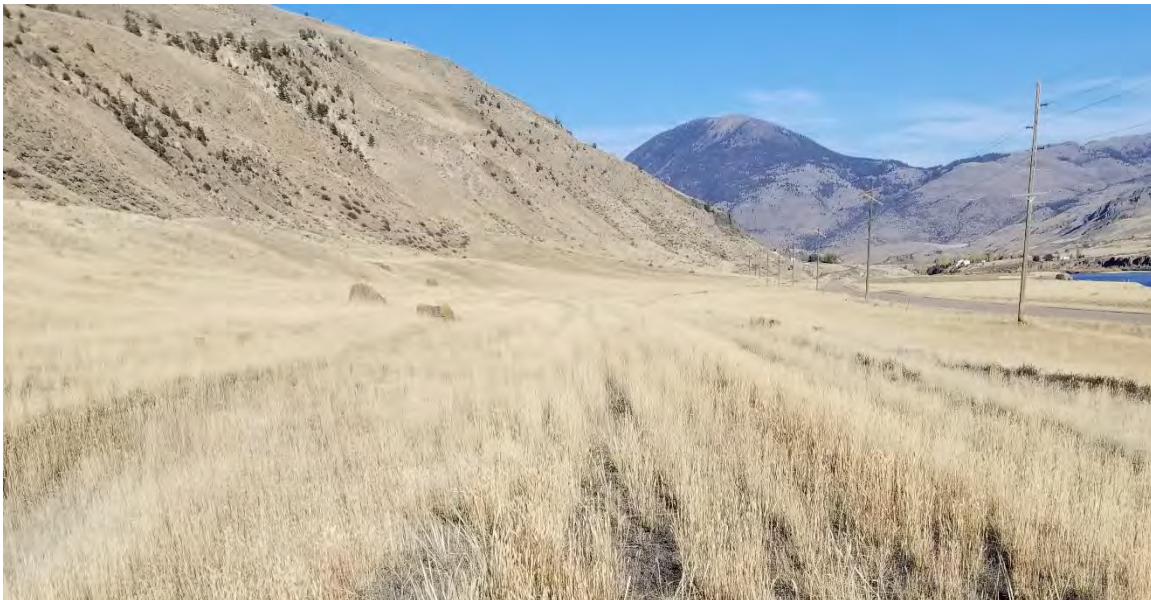
Figure 132 Mile 7. Overgrowth obscures the trail.

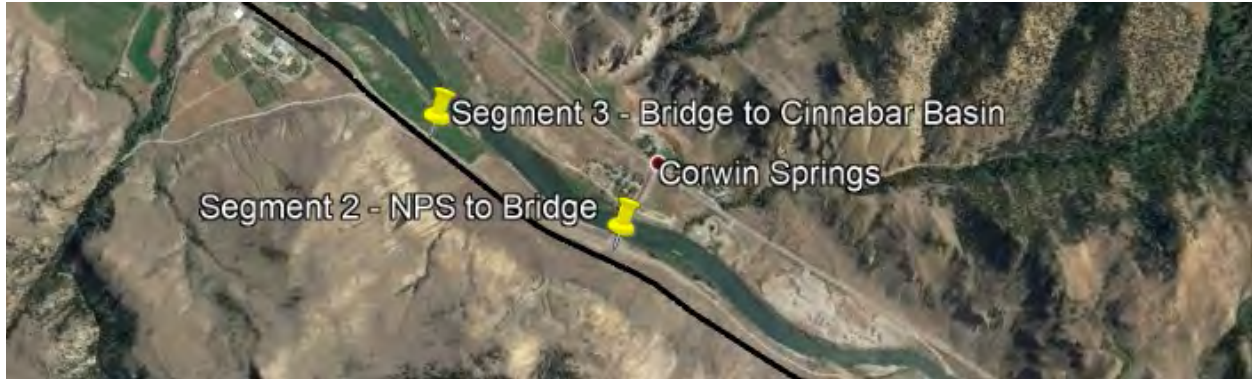
Figure 165 Segment 3 extends from Corwin Springs bridge to Cinnabar Basin Road.

Though this segment is short in length, it has been identified as a standalone segment for its role in providing access to Royal Teton Ranch and the associated traffic volume. The ranch periodically applies dust control between the bridge and the ranch entrance. It is likely the most heavily utilized segment in the corridor, but this assumption will need to be verified with future traffic counts. Royal Teton Ranch generates the majority of the traffic demand, with Cinnabar Basin Road residents producing the remaining demand. There is limited public access off Cinnabar Basin Road. Most of the land ownership is private. There are likely some hunters, hikers and OHV users looking for access or entering areas illegally because there is evidence of these activities in the form of tire tracks and bullet casings.

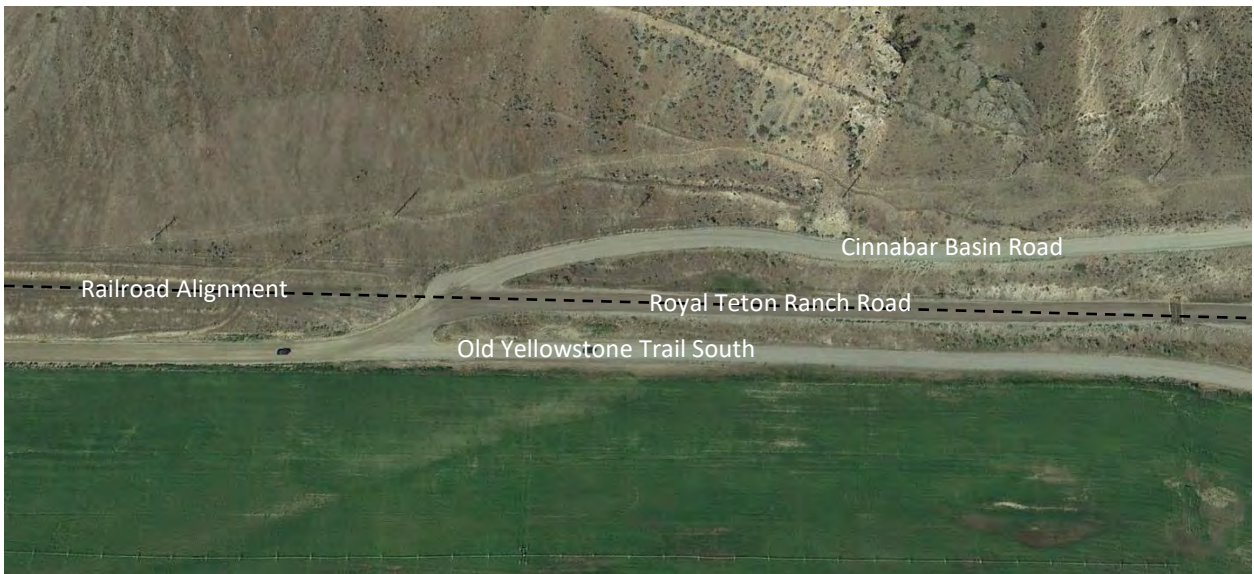
Figure 176 Mile 8.3. Intersection of Old Yellowstone Trail South, Cinnabar Basin Road and Royal Teton Ranch Road. Photo credit: Google Earth

At approximately MP 8.3 the original railroad alignment serves as the access road for Royal Teton Ranch (Figure 16). Cinnabar Basin Road intersects Old Yellowstone Trail South Road where most of the traffic is diverted.

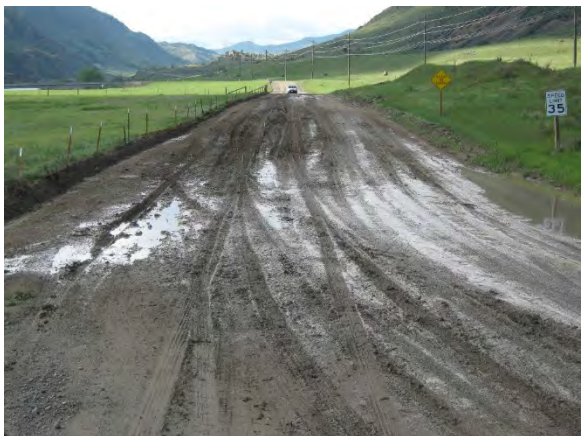
Figure 187 (L) Mile 8.3 looking south on OYTS Road. Drainage is inadequate to handle heavy rains. Photo credit: Alan Shaw; Figure 198 (R) Mile 8.3 Looking south on old railbed.

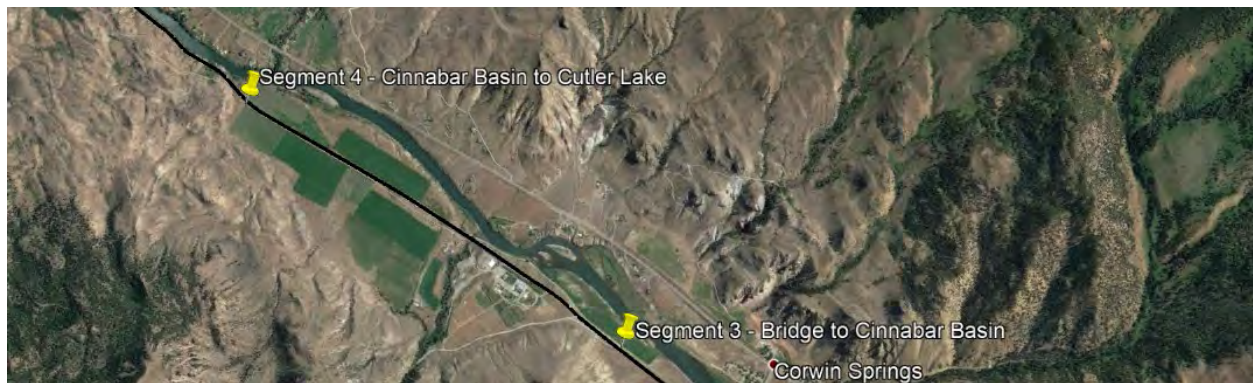
Figure 209 Segment 4 extends from Cinnabar Basin Road to Cutler Lake.

Shortly beyond Cinnabar Basin Road, the roadway and the railbed encounter a chokepoint as they come together to cross Mulherin Creek Bridge. There was once a railroad bridge in this location that is no longer here. The existing roadway bridge should be evaluated, improved or replaced to facilitate access for multi-modal users. North of the bridge, as the segment continues, the classification of the road changes from Class 2 to Class 4 in the Park County roadway classification system, signifying seasonal use as opposed to high priority use<sup>17</sup>. The reduced level of maintenance is reflective of lack of users in the area. What was once the railroad is now essentially non-accessible. A private fence separates the former rail alignment with the roadway, and no trespassing signs communicate the desire to keep recreational users off what was perhaps once a trail.

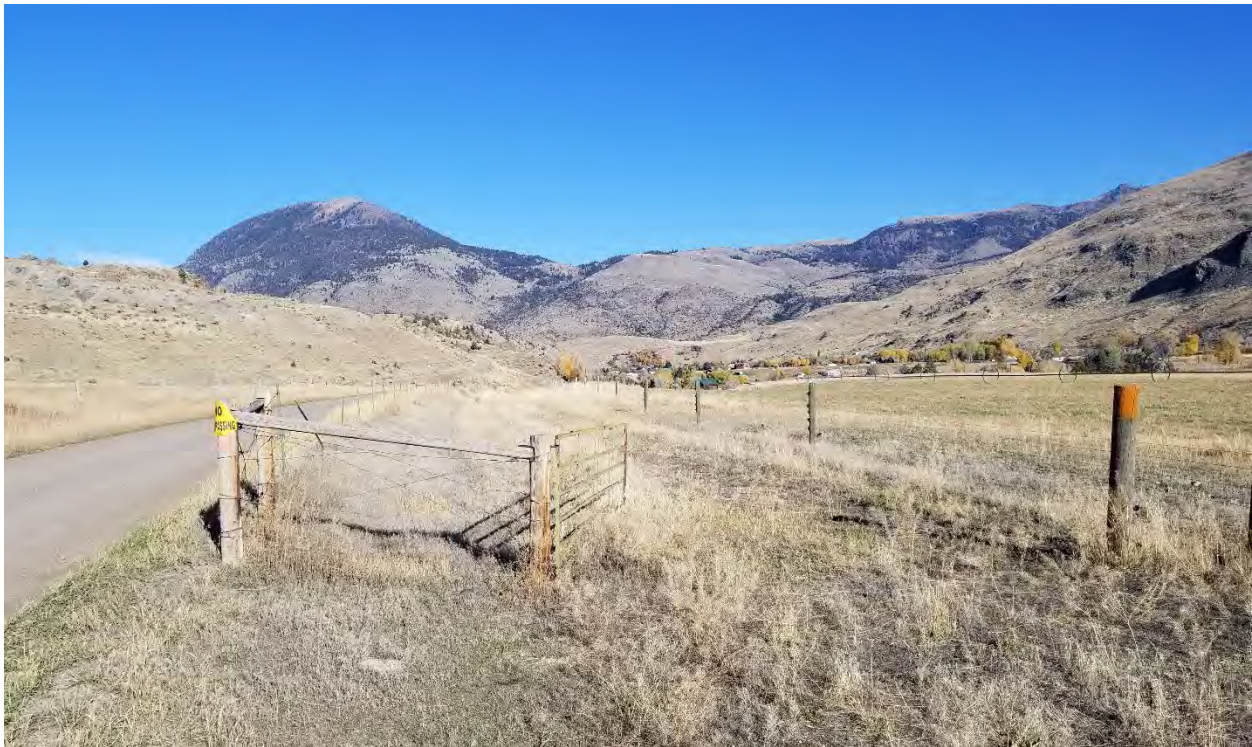
*Figure 20 Mile 9.7. Trail access is plausible, but requires coordination with current land owner.*

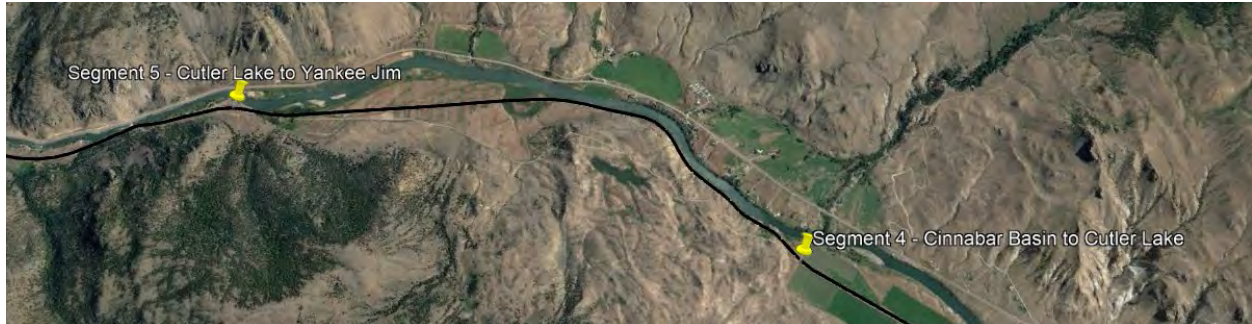
Figure 21 Segment 5 extends from Cutler Lake to Yankee Jim Canyon.

MP 10.6 indicates a significant departure of the railbed from the road. The railbed continues at grade along the river, whereas the road rises up to the crest of Cutler Hill. It likely took a blasting effort in the 1890s to create the original rail line and evidence suggests that rock stabilization was not incorporated into the construction. The integrity of the area has suffered as a result and today this site suffers from rockfall activity and alluvial sediment deposits.

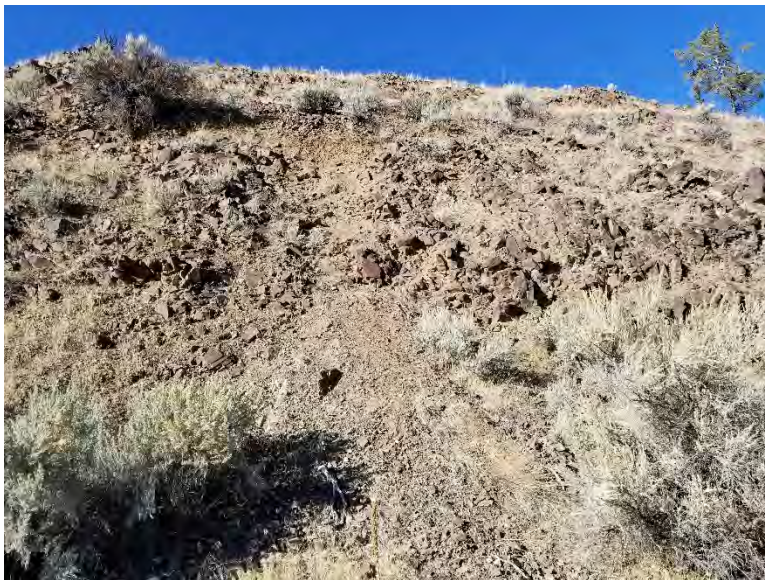
Figure 22 Mile 10.2. Loose Rock.

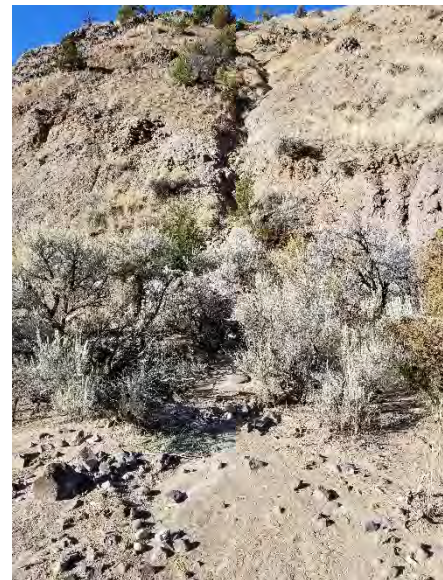
Figure 213 Mile 10.6. Erosion and resulting sediment deposits.

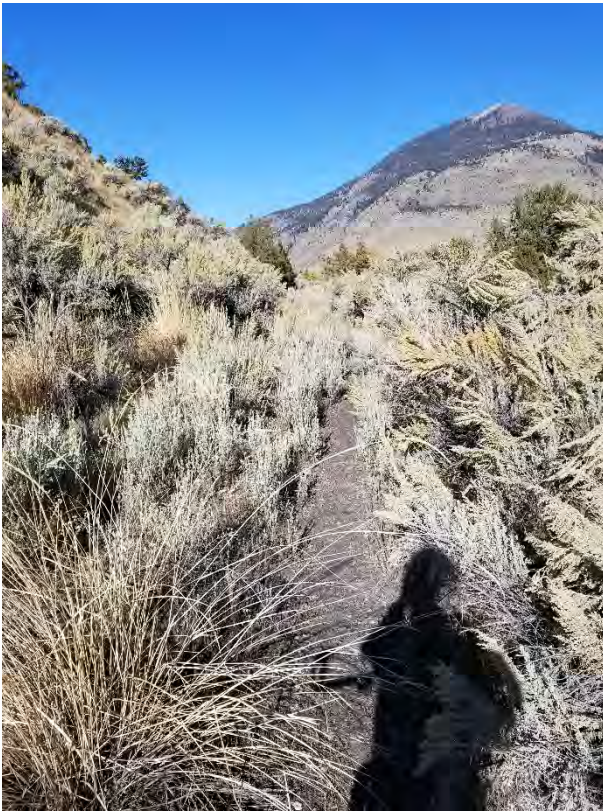
Figure 234 Mile 10.7. Path becomes overgrown.

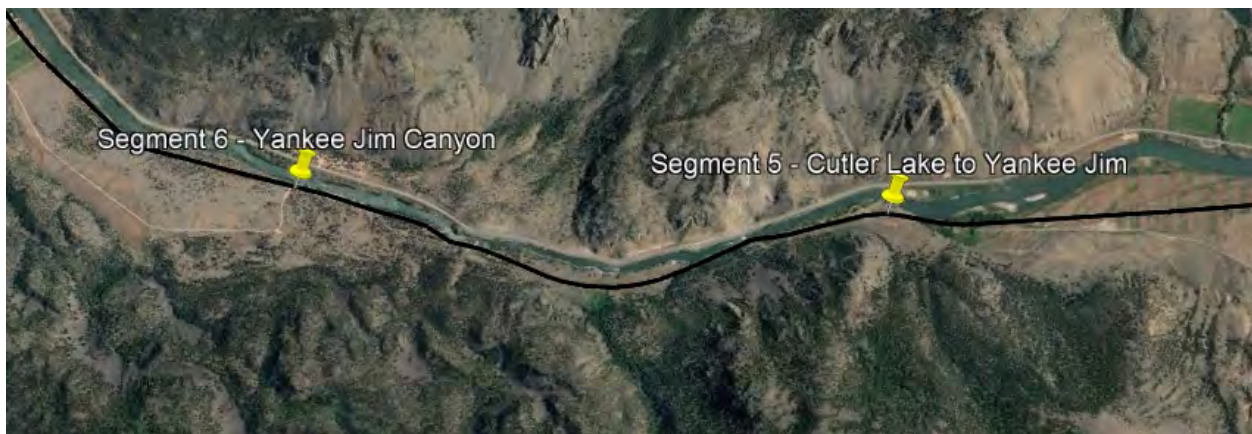
Figure 245 Segment 6 extends from Cutler Meadow to Yankee Jim Canyon

Known trouble areas within the Yankee Jim Canyon segment of the corridor present the greatest challenge for generating a secondary emergency access. A landslide washed out a section of road at

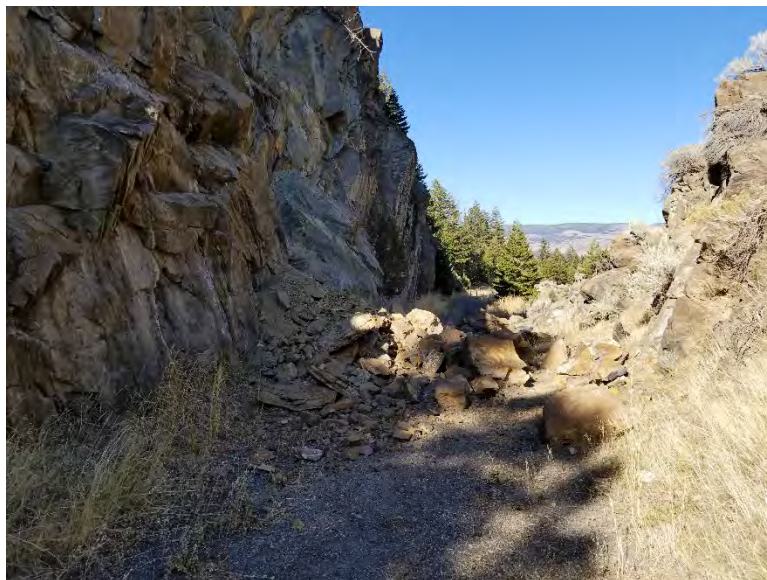
Figure 256 Rockslide at milepost 14.1 looking northwest.

milepost 14.2 in 2011 and a rockslide covered a nearby section of road at milepost 14.1 in 2014. Park County has been unable to restore safe access and has endured the road closure since 2014, a significant obstacle in the desire to establish an alternative emergency access route. There is evidence of off-road vehicles bypassing the road barriers and driving around the landslide, but the rockslide is currently impassible. Alternate routes are possible for bicycle and pedestrian access, but both are also able to navigate around the slides as they exist.

- **Option 1: 20-Foot Road with Minimum Improvements (est. construction cost \$2.0 million)**
  - **Road:**
    - Clear the blockages on the roadway at MP 14.1 and 14.2
    - Undertake low-cost slope stabilization measures
    - Establish consistent 20-foot road width; except keep one-lane width in Yankee Jim Canyon with intervisible turnouts for passing
    - Recondition road with aggregate
    - Improve drainage:
      - Install, replace, repair, or clean culverts where necessary.
      - Construct or clear drainage ditches.
      - Establish crown on roadway
    - Install clear wayfinding signs
  - **Trail:**
    - Formalize existing trailhead
    - Remove rocks and clear and grub vegetation from trail
    - Establish or maintain 6-foot dirt trail where trail is separated from road

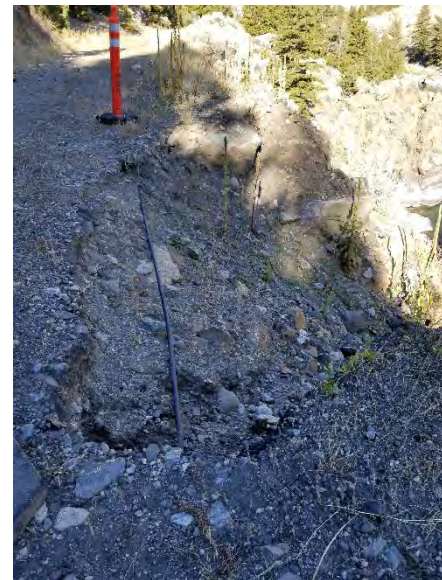
Figure 267 Landslide at milepost 14.2 looking north.

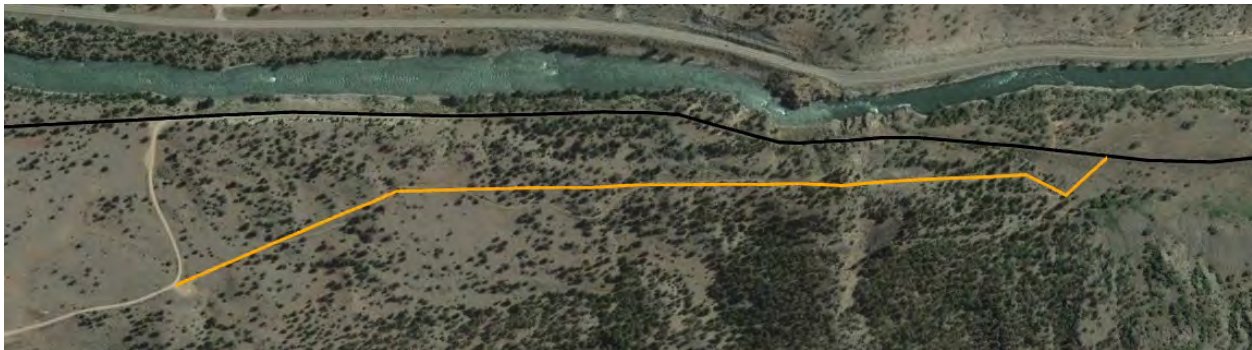
*Figure 278 The orange line highlights the alternate path able to be used by bicycles and pedestrians. Off-road vehicles may be able to navigate this route as well, but it has not been designated as an OHV trail.*

For the length of the segment, the established roadway is completely within the original railbed. Yankee Jim is the most narrow section of the corridor, and with widths ranging from 8 to 12 feet, it is a challenging section to develop if the stated objective is to provide separation between the road and the trail. There is little opportunity to separate the two, unless the trail is established off to the side of the roadway or follows another alignment. A small road branches off the main road and climbs the slopes above the old railroad grade. This roadway could provide opportunity for an optional route, though in its current condition it likely can only serve as a mountain bike trail (figure 25). Before the train line was constructed, it was the only passage through the area. It is tough to imagine that wooden wheeled wagons pulled by a team of horses once passed over this terrain, as it presents a challenge for a knobby-tired mountain bike equipped with suspension.

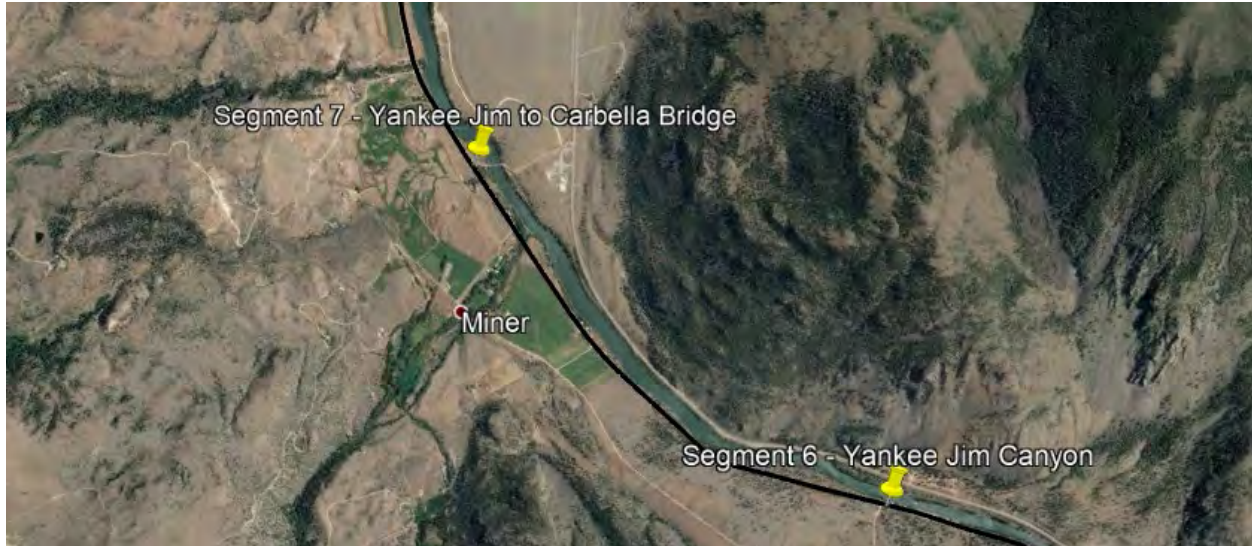
Figure 289 Segment 7 extends from Yankee Jim Canyon to Carbella Bridge

As the road reaches milepost 15.6, the road and the railbed divert from one another. The probability of utilizing the former railbed is assumed to be very low. The old rail alignment continues parallel to the river and serves as a driveway to access a private farm, and is no longer accessible as a public trail. Further north, it skirts a field, ends at a stream where a bridge once stood, continues on the other side, traverses another private property and reconnects into Tom Miner Creek Road at milepost 17.5.

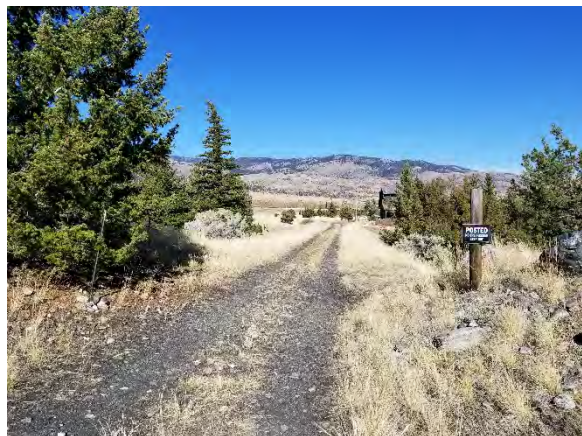
**Road** - Roadway condition is good to excellent in this area. Due to the relatively high number of residences, and the proximity to active farming and recreation, Park County classifies the section of road as a Class 2 – high priority road. Regular grading and maintenance have kept the road in good repair. There are no significant signs of damage to the roadway. The intersection with Tom Miner Creek Road at milepost 17.5 suffers some rutting and dispersion of surface material, but it is anticipated this will be corrected with normal maintenance. During rain events, however, this area becomes muddy and may benefit with rebuilding the roadway subgrade and improving existing drainage.

Figure 30 Mile 14.7 Looking North.

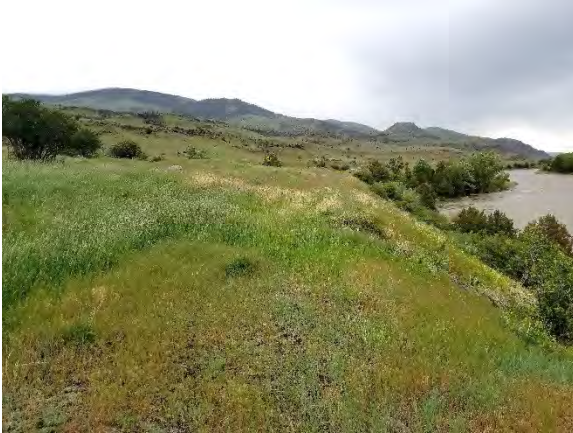
**Trail** - The majority of the rail alignment was not accessible for evaluation during the site survey, as it is contained completely within private property, and is within a private fenceline. As most of the trail was not accessible, it was difficult to assess the condition. It appeared to be well utilized by the property owner as an access road. A limited section that was accessible on foot has been overgrown by grass and shows little to no sign of use.

Figure 312 Mile 16.7. Looking North

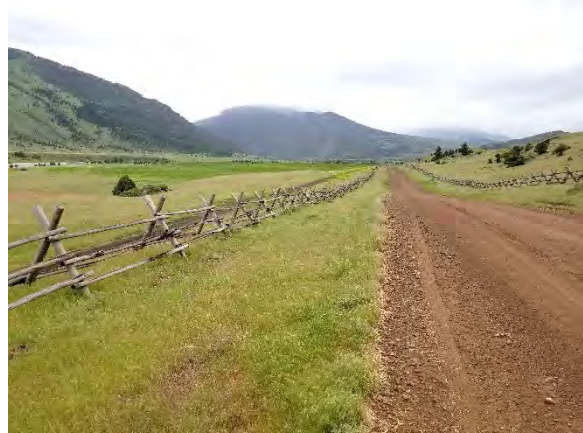
tracks are visible on the roadway. The short section at Point of Rocks had some rippling, an early sign of future washboard surface. As the grade increases, the surface deteriorates and becomes muddy and rippled. Washboard surface develops as the surface dries up and tires spin on the steepness of the slope.

Figure 313 Mile 18. Looking South on OYTS Road.

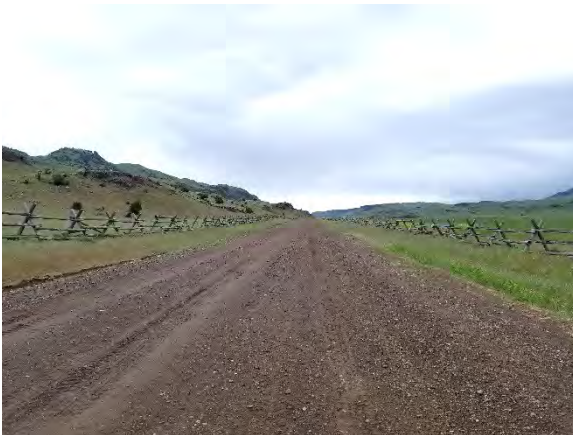
Much like the Cutler Lake segment, beginner cyclists may find the Point of Rocks surface to be loose and bumpy. The steepness of the road, loose gravel, and weather conditions have created a washboard surface that is uncomfortable to drive on, and likely uncomfortable for anything other than a full suspension mountain bike.

Figure 334 Mile 18.6. Looking North on OYTS Road.

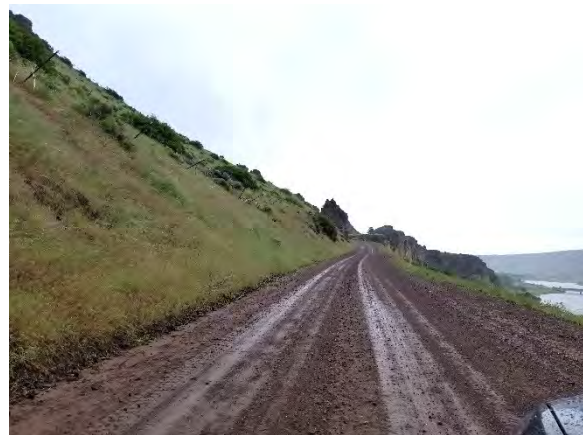
Figure 335 Mile 18.9. Looking North on OYTS Road.

**Geotech** - Point of Rocks is a mix of large rocks and boulders sitting atop a mix of finer grained material. The larger, visible formations on the top with the vertical cliffs are strong and resistant to weathering, but with some weathering taking effect on the finer deposits. Rockfall is possible and already occurring from erosion. Catchment ditches are possible along the road and trail, and are

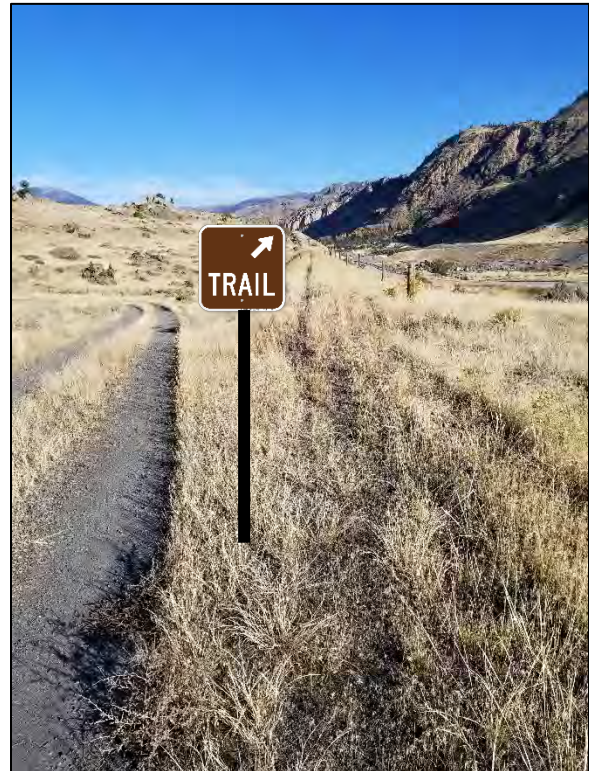
Figure 47 Sample trail directional signage

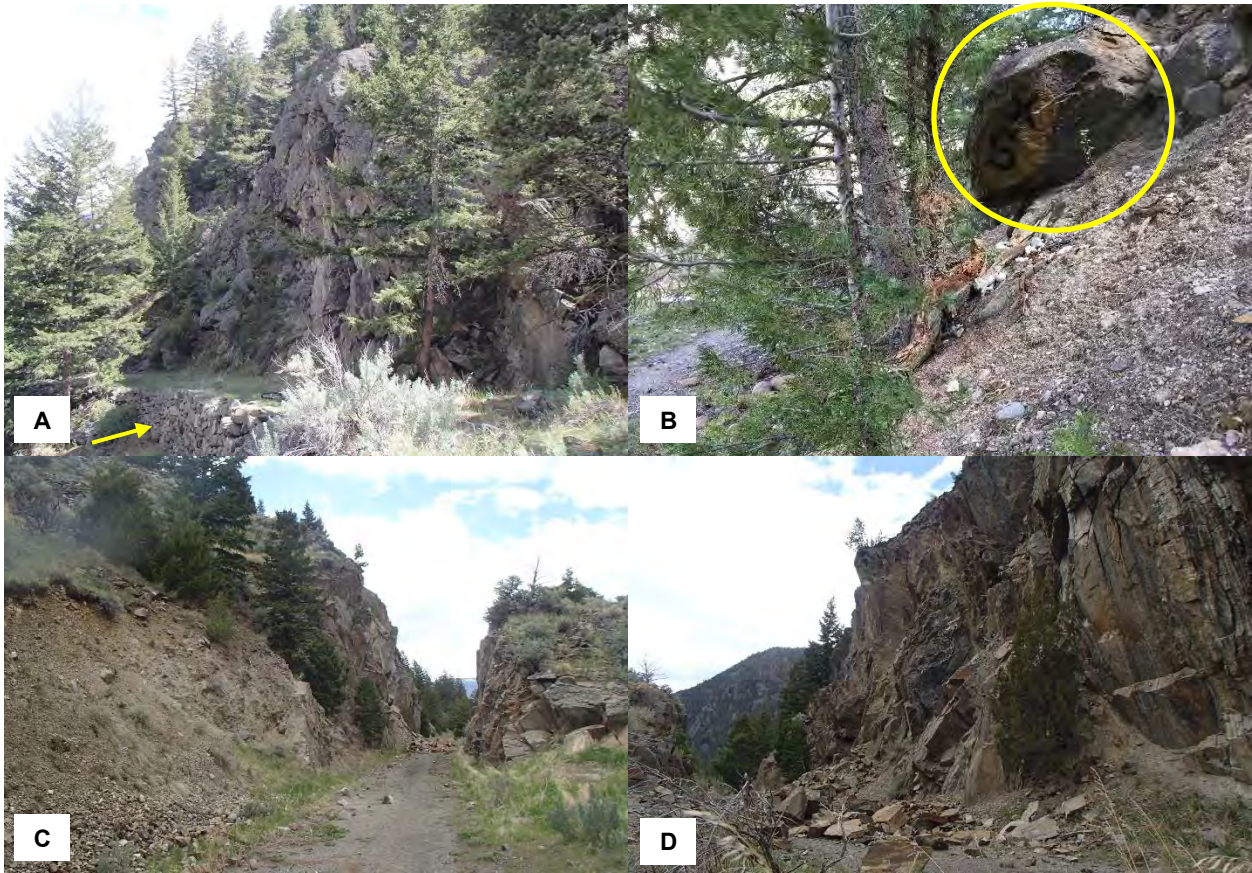
**Figure 5** Photographs of rockfall hazards in the Yankee Jim Canyon section (Appendices A-1 and A-4). **A)** Site US16 looking east (towards Gardiner). The site is along the Yankee Jim Toll Road south sub-section and has historic hand laid drystone rockery wall (yellow arrow). The site has numerous adverse oriented joint sets that allow planar, wedge, and toppling failures. **B)** Site US17 at the western end, looking east. An historic advertisement painted on a boulder is visible (yellow circle). The slope has unconsolidated silty sand and gravel supporting cobble and boulders. **C)** Through cut along the road, sites US103 (left) and US104 (right) looking northwest and **D)** looking southeast. Large rockfall was observed coming off of site US103. Numerous adverse oriented joint sets that allow planar, wedge, and toppling failures.

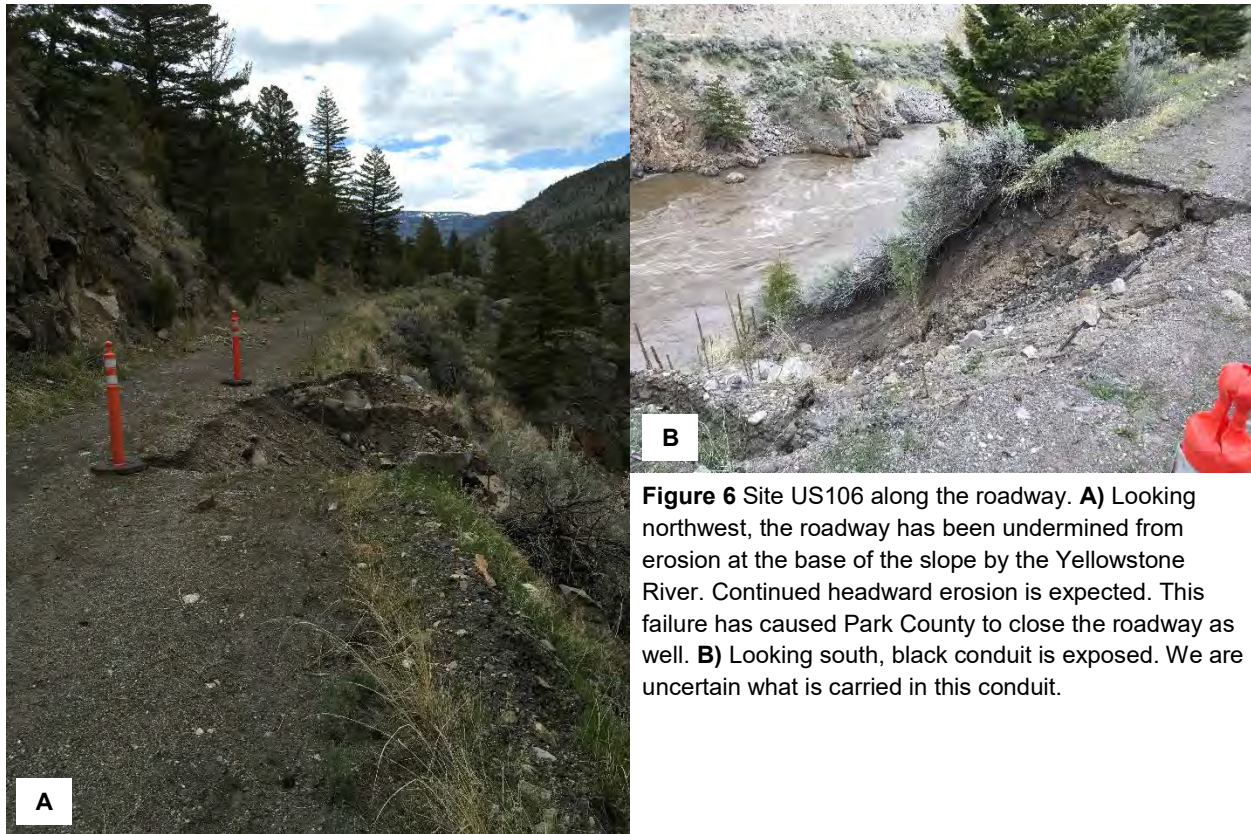
**B**

Site US106 is a failure affecting half of the roadway (the old railroad grade; Figure 6). Within the exposed headscarp utility conduit was exposed. We were uncertain of the nature of the conduit however. This failure has caused the County to close the road and from our understanding was initiated about 2 years ago, during high flows along the Yellowstone River.

**Figure 6** Site US106 along the roadway. **A)** Looking northwest, the roadway has been undermined from erosion at the base of the slope by the Yellowstone River. Continued headward erosion is expected. This failure has caused Park County to close the roadway as well. **B)** Looking south, black conduit is exposed. We are uncertain what is carried in this conduit.

Mitigation efforts for the landslide slopes could entail keyed in retaining walls, or cutting further into the cut slope to extend the distance the roadway has from the Yellowstone River's erosional banks. Surface and subsurface drainage improvements could also provide some reprieve from these hazards as well.

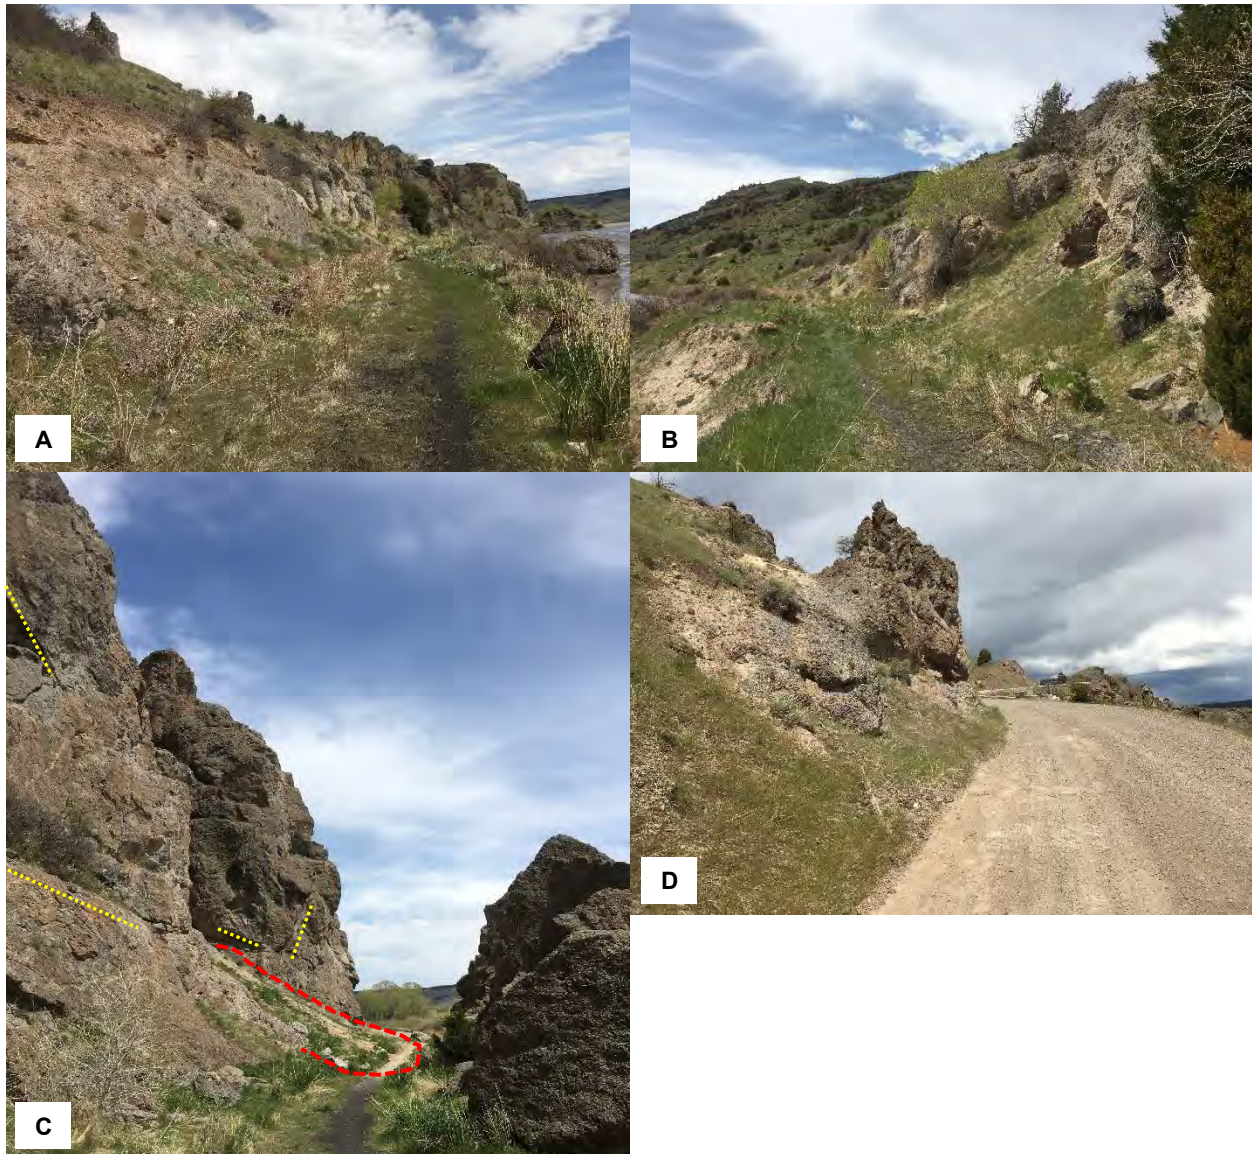
**Figure 7** Photographs of rockfall hazards in the Point of Rocks section (Appendices A-1 and A-5). **A)** Site US19 looking north, with the Yellowstone River on the right. Differential erosion rockfall hazard with a limited ditch catchment along the old rail road grade. **B)** Site US19 looking south. **C)** Site US21 looking north. Joint sets are observed in the bedrock (yellow dashed lines) that facilitate planar, wedge, and indeterminate failures off of the 85-foot high bedrock outcrop. A debris flow is observed covering the proposed trail (outlined in dashed red) up to 3 feet deep. The trail curves around the outside edge of the debris fan. Dashed yellow lines highlight joint surfaces, some of which are adverse and consistent with others being indeterminate, or inconsistent. **D)** Site US110 looking north. Similar Hyalite volcanics as at site US21 (photograph **C**).
