2020

# Old Yellowstone Trail South Corridor Study

Park County Montana

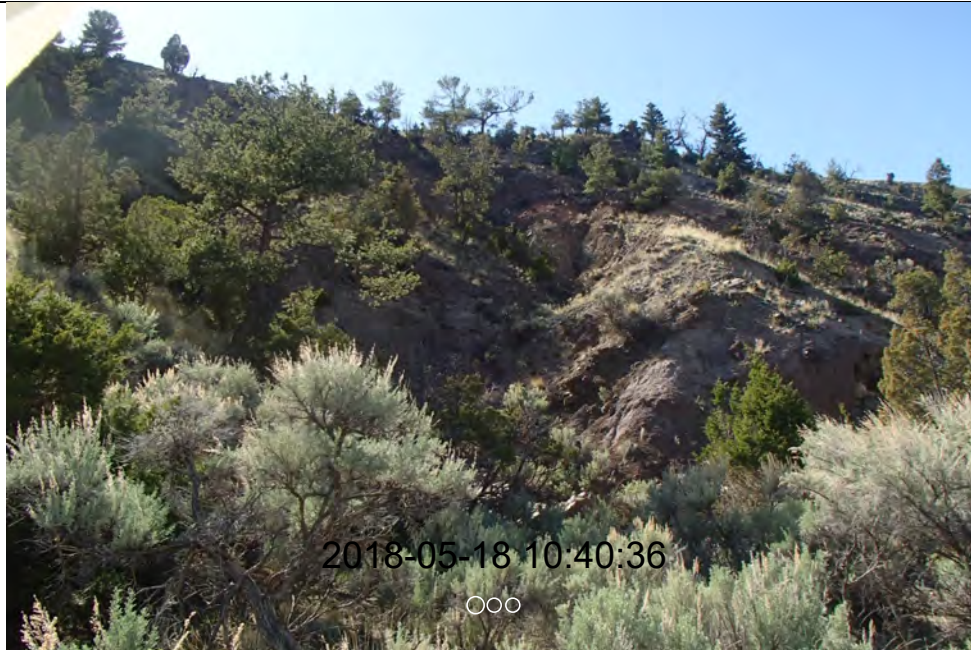
Slope Rating Form - Site Information (Rockfall)			
Management Area: OTHER <input type="text"/>	Date: 2018-05-18 12:19:54 Last edit: 2018-05-18 11:10:11	<input checked="" type="radio"/> Rockfall <input type="radio"/> Landslide	Hazard Type: Press (ctrl+click) to select more than one Raveling/Undermining Rock Avalanche Indeterminate Rock Failures Diff. Erosion
Montana <input type="text"/> Park County <input type="text"/>	Road/Trail No: OYTS US11 Road/Trail: T <input type="text"/>	Road/Trail Class: Proposed <input type="text"/>	Rater: OG NJ <input type="text"/>
Beginning Mile Marker: 0 <input type="text"/>	Ending Mile Marker: 0 <input type="text"/>	Side: E - IF ROAD DIREC <input type="text"/>	Weather: A Few Clouds <input type="text"/>
Begin Coord. Lat/Long: Lat (###.#####): 45.15003 Long (-###.#####): -110.82222	End Coord. Lat/Long: Lat (###.#####): 45.15044 Long (-###.#####): -110.82228	Datum: WGS 84 <input type="text"/>	AADT: 0 <input type="text"/>

Length of Affected Road/T rail (ft): 440 <input type="text"/>	Slope Height (rock)/Axial Length (slide) (ft): 160 <input type="text"/>	Slope Angle (°): 40 <input type="text"/>	
Sight Distance (ft): 350 <input type="text"/>	Usable Roadway/T rail Width (ft): 12 <input type="text"/>	Speed Limit (mph): 2 <input type="text"/>	
Ditch Width Range (ft): 15 -20 <input type="text"/>	Ditch Depth Range (ft): 0 -0 <input type="text"/>	Ditch Slope Range (H:V): 0:0 -0:0 <input type="text"/>	Block Size (ft): 1.5 <input type="text"/> Volume (cy): 0 <input type="text"/>
Annual Rainfall Range (in): 10 -20 <input type="text"/>	Sole Access Route: No <input type="text"/>	Mitigation Present: NO <input type="text"/>	Photos/Documents(up to 10MB): <input type="button" value="Choose Files"/> No file chosen

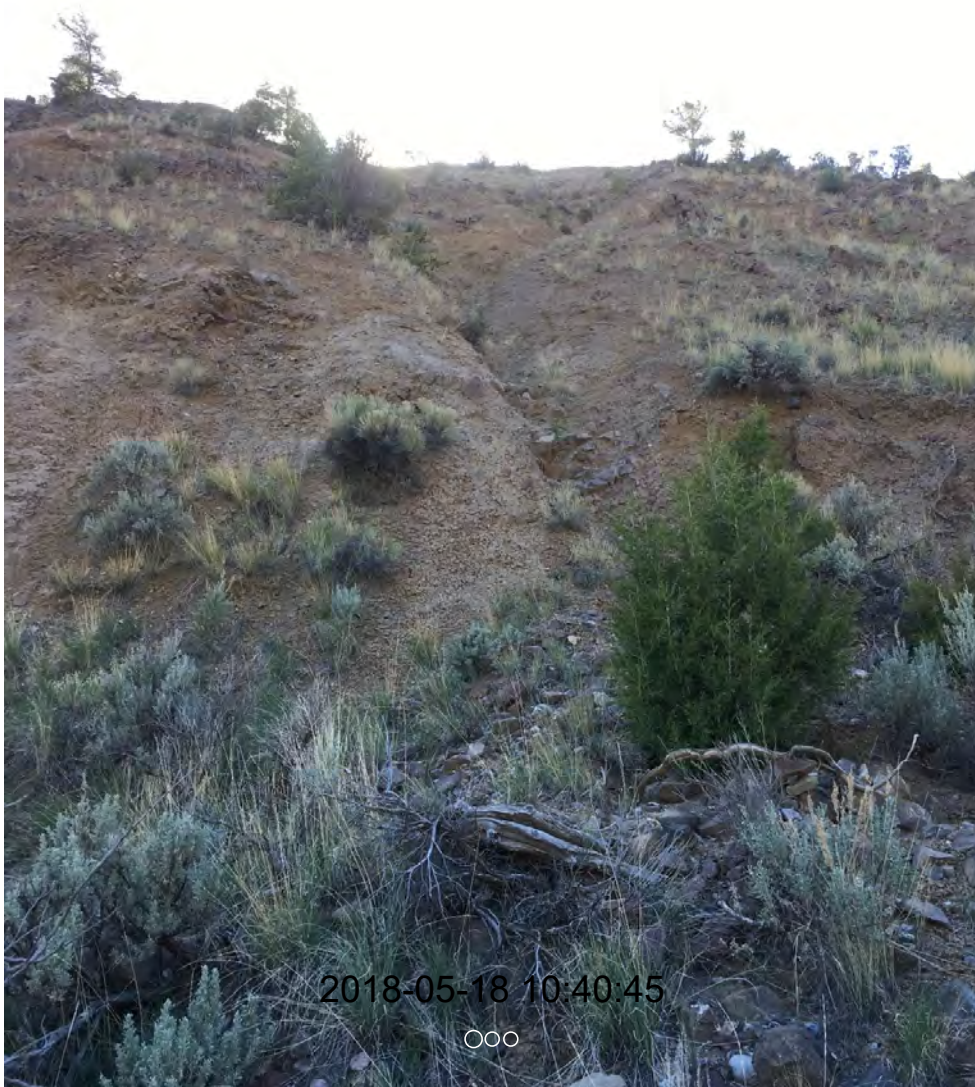
Slope Rating Form - Site Information (Landslide)					
Management Area: OTHER <input type="text"/>	Date: 2018-05-18 12:20:35 Last edit: 2018-05-18 11:09:58	<input type="radio"/> Rockfall <input checked="" type="radio"/> Landslide	Hazard Type: Press (ctrl+click) to select more than one Diff. Erosion Translational Rotational Debris Flow		
Montana <input type="text"/> Park County <input type="text"/>	Road/Trail No: OYTS US13 Road/Trail: T <input type="text"/>	Road/Trail Class: Proposed <input type="text"/>	Rater: OG NJ <input type="text"/>		
Beginning Mile Marker: 0 <input type="text"/>	Ending Mile Marker: 0 <input type="text"/>	Side: E - IF ROAD DIREC <input type="text"/>	Weather: A Few Clouds <input type="text"/>		
Begin Coord. Lat/Long: Lat (##.#####): 45.15159 Long (-###.#####): -110.82251	End Coord. Lat/Long: Lat (##.#####): 45.15155 Long (-###.#####): -110.82219	Datum: WGS 84 <input type="text"/>	AADT: 0 <input type="text"/>

Length of Affected Road/T rail (ft): 70 <input type="text"/>	Slope Height (rock)/Axial Length (slide) (ft): 450 <input type="text"/>		Slope Angle (°): 36 <input type="text"/>		
Sight Distance (ft): 400 <input type="text"/>	Usable Roadway/T rail Width (ft): 12 <input type="text"/>		Speed Limit (mph): 2 <input type="text"/>		
Ditch Width Range (ft): 0 - 0 <input type="text"/>	Ditch Depth Range (ft): 0 - 0 <input type="text"/>	Ditch Slope Range (H:V): 0:0 - 0:0 <input type="text"/>	Block Size (ft): 0 <input type="text"/> Volume (cy): 0 <input type="text"/>		
Annual Rainfall Range (in): 10 - 20 <input type="text"/>	Sole Access Route: No <input type="text"/>	Mitigation Present: NO <input type="text"/>	Photos/Documents(up to 10MB): <input type="button" value="Choose Files"/> No file chosen		
Comments: Localized debris flow shoot incised into slope, ~2' debris on trail. Cutler Lake Landslide section. [originally designated as site US23]

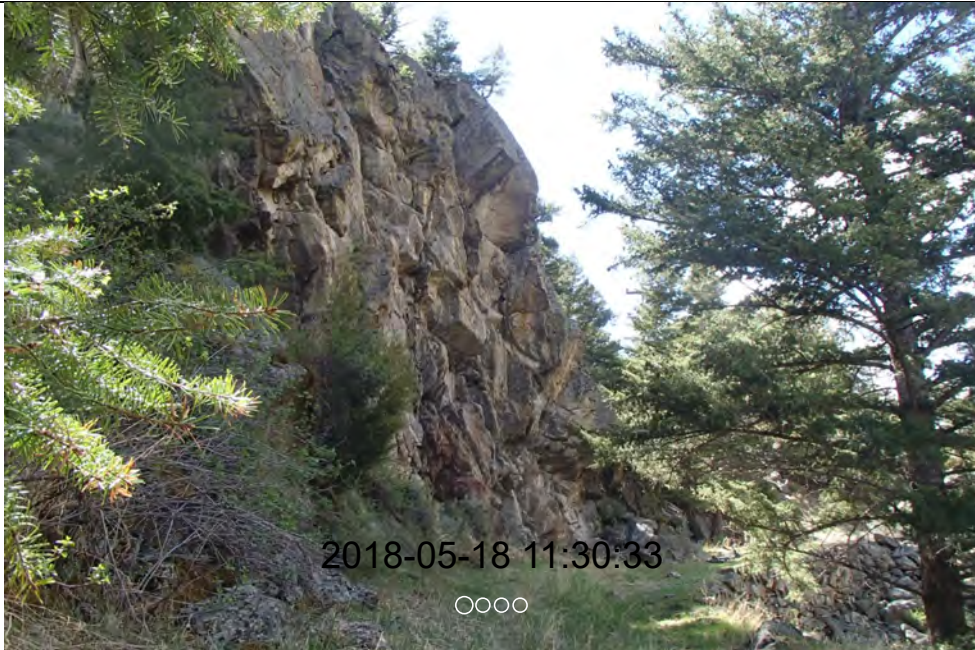
Slope Rating Form - Site Information (Rockfall)					
Management Area: OTHER <input type="text"/>		Date: 2018-05-18 12:22:48 Last edit: 2018-05-18 11:34:55		Hazard Type: Press (ctrl+click) to select more than one Raveling/Undermining Rock Avalanche Indeterminate Rock Failures Diff. Erosion	
Montana <input type="text"/> Park County <input type="text"/>		<input type="radio"/> Rockfall <input type="radio"/> Landslide			
Road/Trail No: OYTS US17	Road/Trail: T	Road/Trail Class: Proposed	Rater: OG NJ		
Beginning Mile Marker: 0	Ending Mile Marker: 0	Side: NE - IF ROAD DIRE	Weather: A Few Clouds		
Begin Coord. Lat/Long: Lat (##.#####): 45.17498 Long (-###.#####): -110.88188	End Coord. Lat/Long: Lat (##.#####): 45.17586 Long (-###.#####): -110.88278	Datum: WGS 84	AADT: 0		
Length of Affected Road/T rail (ft): 425	Slope Height (rock)/Axial Length (slide) (ft): 25		Slope Angle (°): 45		
Sight Distance (ft): 60	Usable Roadway/T rail Width (ft): 5		Speed Limit (mph): 2

Ditch Width Range (ft): 0 -2	Ditch Depth Range (ft): 0 -0	Ditch Slope Range (H:V): 0:0 -0:0	Block Size (ft): 2 Volume (cy): 0		
Annual Rainfall Range (in): 10 -20	Sole Access Route: No	Mitigation Present: NO	Photos/Documents(up to 10MB): Choose Files No file chosen		
Comments: Cut slope oversteepened with loose rock on slope above but much less. Boulders up to 4' observed on trail, but avg 1-2', historic dry stone wall on fill side trail in good condition. Historic sign painted on rock in slope near End. Yankee Jim Toll Road 2 section. [originally designated site US16]					
Alternate database Name:			Alternate database ID:		
Alternate database Description:					
Preliminary Ratings					
Category Rating:	3	9	27	81	Score:

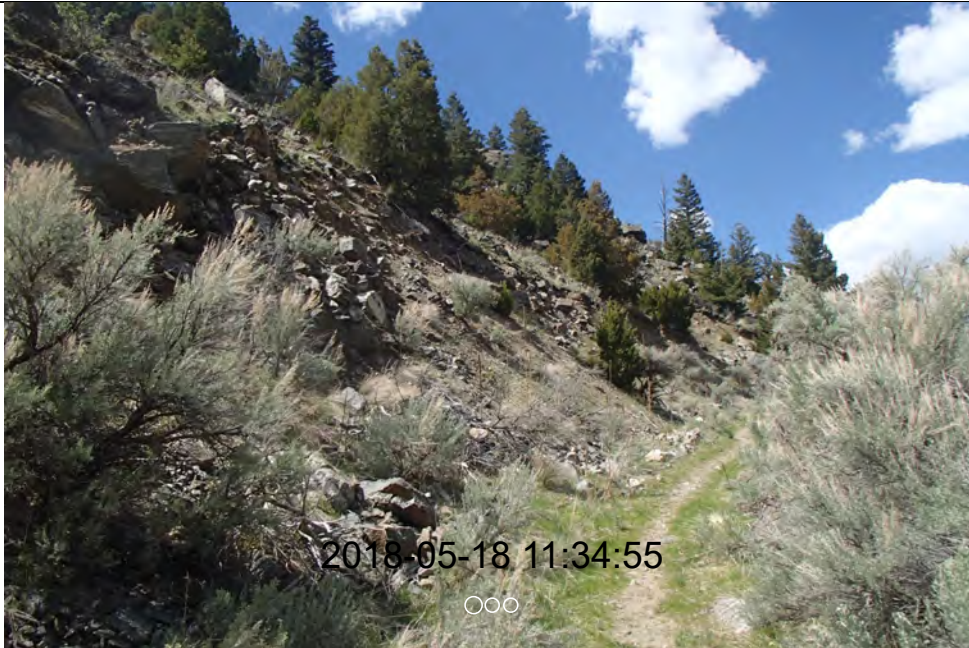
Slope Rating Form - Site Information (Rockfall)					
Management Area: OTHER <input type="text"/>		Date: 2018-05-18 12:23:49 Last edit: 2018-05-18 11:35:18		Hazard Type: Press (ctrl+click) to select more than one <input type="checkbox"/> Rockfall <input type="checkbox"/> Landslide Raveling/Undermining Rock Avalanche Indeterminate Rock Failures Diff. Erosion	
Montana <input type="text"/> Park County <input type="text"/>		Road/Trail No: OYTS US18 Road/Trail: T <input type="text"/>		Road/Trail Class: Proposed <input type="text"/> Rater: OG NJ <input type="text"/>	
Beginning Mile Marker: 0 <input type="text"/>		Ending Mile Marker: 0 <input type="text"/>		Side: NE - IF ROAD DIRE <input type="text"/> Weather: A Few Clouds <input type="text"/>	
Begin Coord. Lat/Long: Lat (##.#####): 45.17591 Long (-###.#####): -110.8828		End Coord. Lat/Long: Lat (##.#####): 45.17733 Long (-###.#####): -110.88508		Datum: WGS 84 <input type="text"/> AADT: 0 <input type="text"/>

Length of Affected Road/T rail (ft): 775 <input type="text"/>		Slope Height (rock)/Axial Length (slide) (ft): 25 <input type="text"/>		Slope Angle (°): 45 <input type="text"/>	
Sight Distance (ft): 75 <input type="text"/>		Usable Roadway/T rail Width (ft): 5 <input type="text"/>		Speed Limit (mph): 2 <input type="text"/>	
Ditch Width Range (ft): 0 -2 <input type="text"/>		Ditch Depth Range (ft): 0 -0 <input type="text"/>		Ditch Slope Range (H:V): 0:0 -0:0 <input type="text"/>	
Annual Rainfall Range (in): 10 -20 <input type="text"/>		Sole Access Route: No <input type="text"/>		Mitigation Present: NO <input type="text"/> Block Size (ft): 2 <input type="text"/> Volume (cy): 0 <input type="text"/>	
Photos/Documents(up to 10MB): <input type="button" value="Choose Files"/> No file chosen		Comments: Slope begins in foliated and folded garnet schist gneiss with copious biotite, but little perceived risk, risk most hazardous portion appears in differentially eroding portion. clasts rounded to angular, up to 3', supported by silty sand and gravel. Historic dry stone wall on fill side. Yankee Jim Toll Road 2 section. [originally designated site]

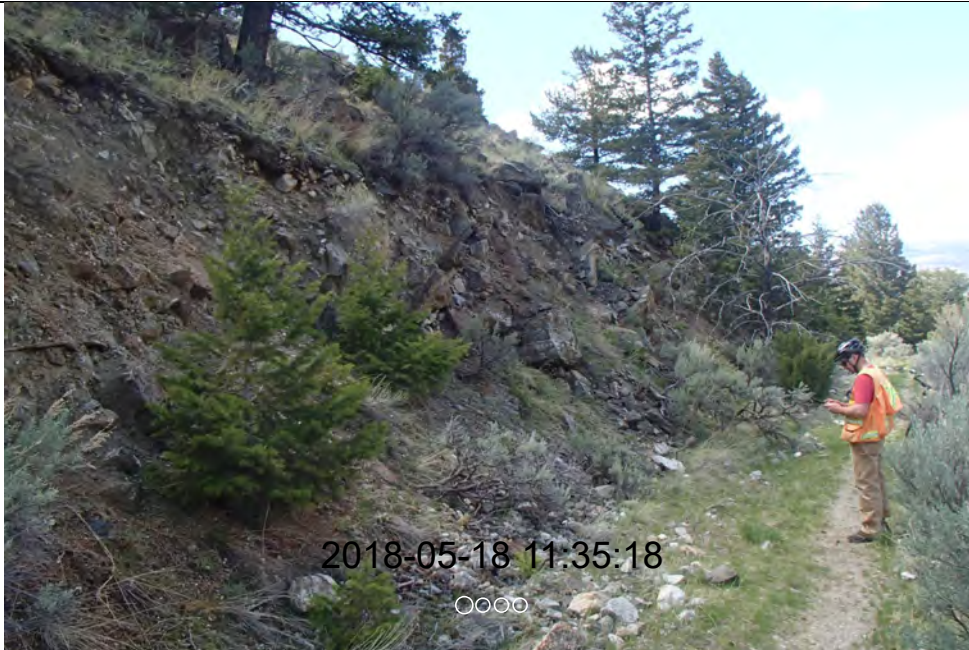
Slope Rating Form - Site Information (Rockfall)					
<b>Management Area:</b> OTHER <input type="text"/> Montana <input type="text"/> Park County <input type="text"/>		Date: 2018-05-18 12:26:09 Last edit: 2018-05-18 12:01:19		Hazard Type: Press (ctrl+click) to select more than one <input checked="" type="radio"/> Rockfall <input type="radio"/> Landslide Raveling/Undermining Rock Avalanche Indeterminate Rock Failures Diff. Erosion	
Road/Trail No: OYTS US19	Road/Trail: T	Road/Trail Class: Proposed	Rater: OG		
Beginning Mile Marker: 0	Ending Mile Marker: 0	Side: NE - IF ROAD DIRE	Weather: A Few Clouds and B		
Begin Coord. Lat/Long: Lat (###.#####): 45.25113 Long (-###.#####): -110.87351	End Coord. Lat/Long: Lat (###.#####): 45.25231 Long (-###.#####): -110.8732	Datum: WGS 84	AADT: 0		
Length of Affected Road/T rail (ft): 277	Slope Height (rock)/Axial Length (slide) (ft): 33		Slope Angle (°): 53		
Sight Distance (ft): 620	Usable Roadway/T rail Width (ft): 4		Speed Limit (mph): 2

Ditch Width Range (ft): 0 - 4	Ditch Depth Range (ft): 0 - 0	Ditch Slope Range (H:V): 0:0 - 0:0	Block Size (ft): 2 Volume (cy): 0		
Annual Rainfall Range (in): 10 - 20	Sole Access Route: No	Mitigation Present: NO	Photos/Documents(up to 10MB): <input type="button" value="Choose Files"/> No file chosen		
Comments: Volcanic breccia? Or glacial Till? Light gray weak to moderately strong bedrock with gravel to boulders up to 3' supported by weakly cemented matrix (fine grained material to coarse sand) angular to rounded. Trail on a fill and well armored against cutting by Yellowstone River, in a cut bank, however at end of section bank is eroding					
Alternate database Name:			Alternate database ID:		
Alternate database Description:					
Preliminary Ratings					
Category Rating:	3	9	27	81	Score:

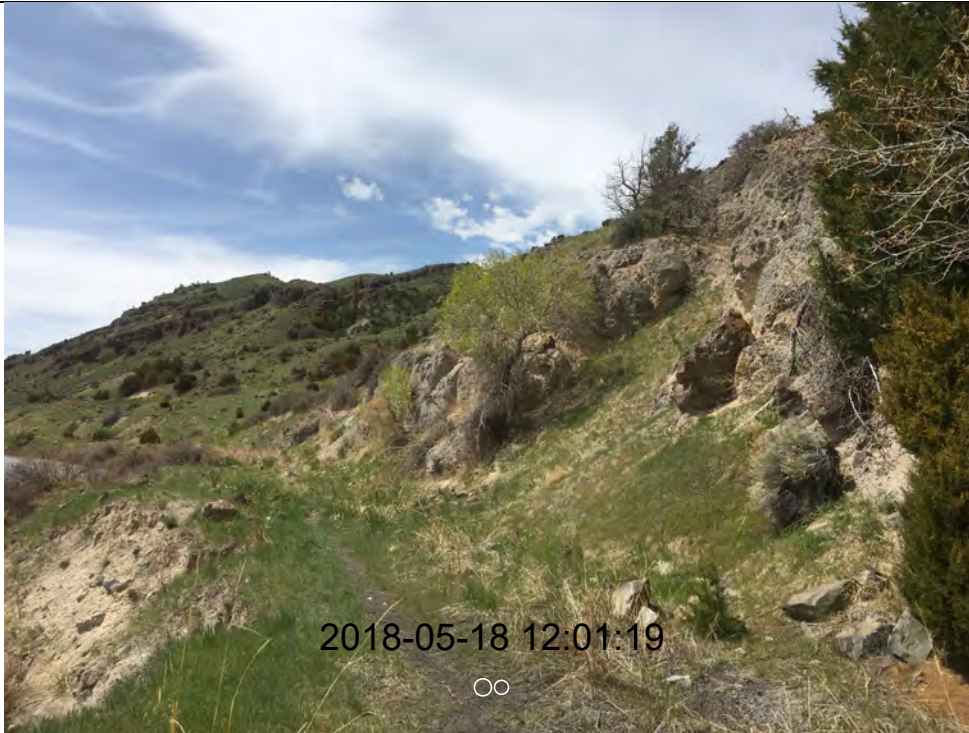
Slope Rating Form - Site Information (Landslide)					
Management Area: OTHER <input type="text"/>		Date: 2018-05-18 12:26:27 Last edit: 2018-05-18 12:01:24		Hazard Type: Press (ctrl+click) to select more than one Rotational Debris Flow Shallow Slump Erosional Failure	
Montana <input type="text"/> Park County <input type="text"/>		<input type="radio"/> Rockfall <input checked="" type="radio"/> Landslide			
Road/Trail No: OYTS US20	Road/Trail: T	Road/Trail Class: Proposed	Rater: OG		
Beginning Mile Marker: 0	Ending Mile Marker: 0	Side: SW - IF ROAD DIRE	Weather: Mostly Cloudy and B		
Begin Coord. Lat/Long: Lat (###.#####): 45.25221 Long (-###.#####): -110.87343	End Coord. Lat/Long: Lat (###.#####): 45.25279 Long (-###.#####): -110.87264	Datum: WGS 84	AADT: 0		
Length of Affected Road/T rail (ft): 287	Slope Height (rock)/Axial Length (slide) (ft): 19		Slope Angle (°): 40		
Sight Distance (ft): 230	Usable Roadway/T rail Width (ft): 12		Speed Limit (mph): 2

Ditch Width Range (ft): 0 - 0	Ditch Depth Range (ft): 0 - 0	Ditch Slope Range (H:V): 0:0 - 0:0	Block Size (ft): 0 Volume (cy): 0		
Annual Rainfall Range (in): 10 - 20	Sole Access Route: No	Mitigation Present: NO	Photos/Documents(up to 10MB): Choose Files No file chosen		
Comments: Cut bank of Yellowstone actively eroding into embankment. No armor if present, besides apparent native boulders sporadically located. Wooden pier present, unknown origin. Buried fiber at middle of site under Trail. Bank material lt gray, loose supporting boulders up to 3,5 ft observed. Trail eroded to about 4' in locations. Mid					
Alternate database Name:			Alternate database ID:		
Alternate database Description:					
Preliminary Ratings					
Category Rating:	3	9	27	81	Score:

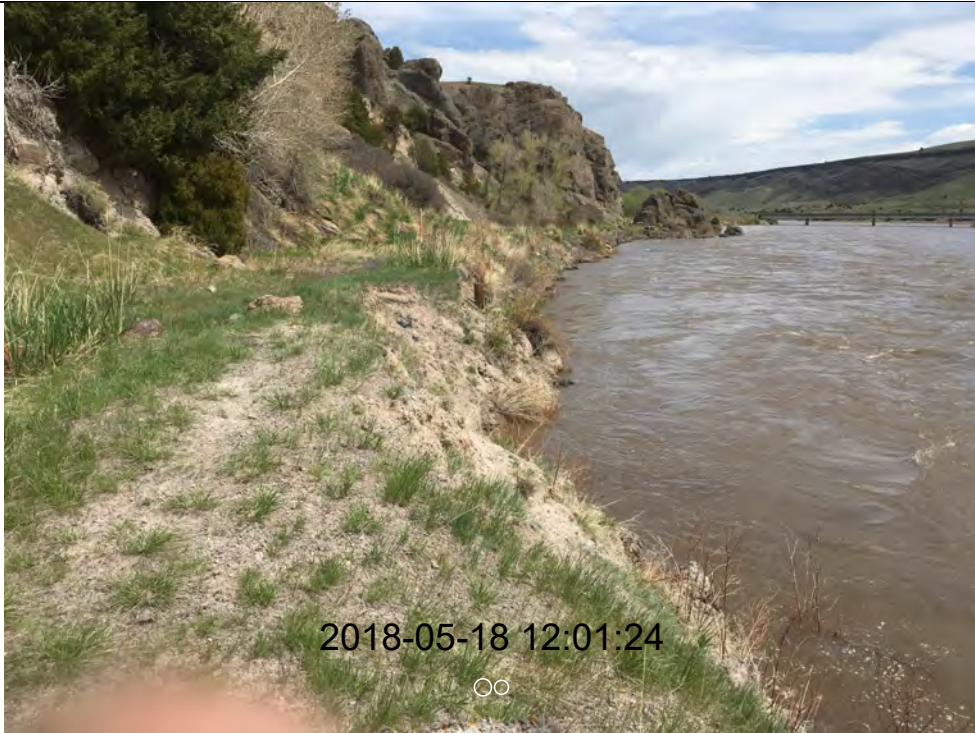
Slope Rating Form - Site Information (Rockfall)					
Management Area: OTHER <input type="text"/>		Date: 2018-05-18 12:26:49 Last edit: 2018-05-18 12:01:33		Hazard Type: Press (ctrl+click) to select more than one Toppling Raveling/Undermining Rock Avalanche Indeterminate Rock Failures	
Montana <input type="text"/> Park County <input type="text"/>		<input checked="" type="radio"/> Rockfall <input type="radio"/> Landslide			
Road/Trail No: OYTS US21	Road/Trail: T	Road/Trail Class: Proposed	Rater: OG		
Beginning Mile Marker: 0	Ending Mile Marker: 0	Side: NW - IF ROAD DIRE	Weather: A Few Clouds and B		
Begin Coord. Lat/Long: Lat (###.#####): 45.25325 Long (-###.#####): -110.87178	End Coord. Lat/Long: Lat (###.#####): 45.25344 Long (-###.#####): -110.87121	Datum: WGS 84	AADT: 0		
Length of Affected Road/T rail (ft): 70	Slope Height (rock)/Axial Length (slide) (ft): 85		Slope Angle (°): 60		
Sight Distance (ft): 150	Usable Roadway/T rail Width (ft): 6		Speed Limit (mph): 2

Ditch Width Range (ft): 0 -4	Ditch Depth Range (ft): 0 -0	Ditch Slope Range (H:V): 0:0 -0:0	Block Size (ft): 2 Volume (cy): 0		
Annual Rainfall Range (in): 10 -20	Sole Access Route: No	Mitigation Present: NO	Photos/Documents(up to 10MB): <input type="button" value="Choose Files"/> No file chosen		
Comments: Tall bedrock cut on NE side and smaller cut on SW Side. Alluvial fan with ~2.5 ' of material on trail mid-site from debris chute. Boulders up to 3' on either side of trail. Point of Rocks section. [originally designated site US28]					
Alternate database Name:			Alternate database ID:		
Alternate database Description:					
Preliminary Ratings					
Category Rating:	3	9	27	81	Score:

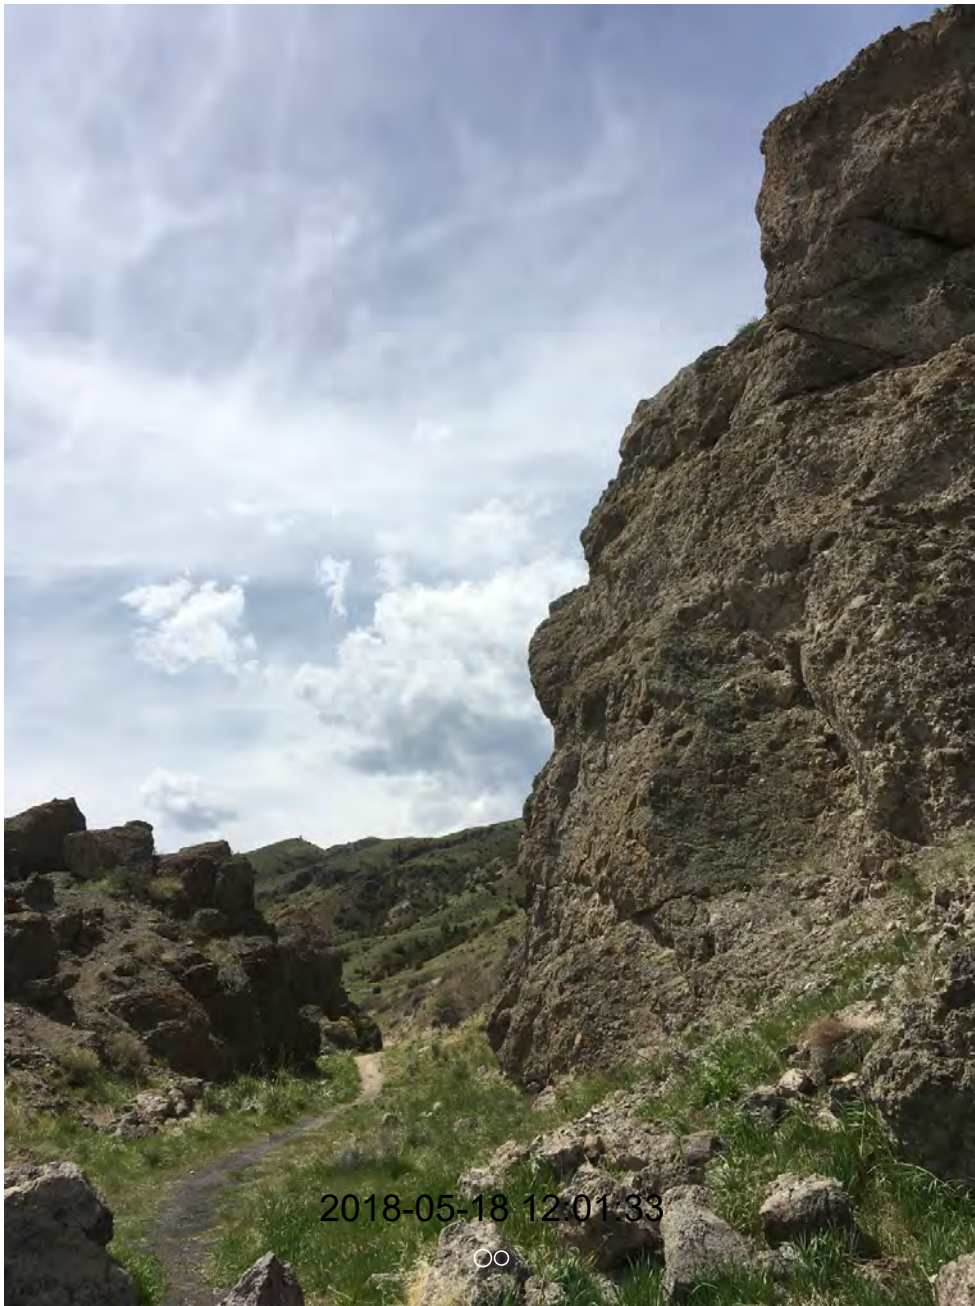
Slope Rating Form - Site Information (Landslide)			
Management Area: OTHER <input type="text"/> Montana <input type="text"/> Park County <input type="text"/>	Date: 2018-05-18 12:27:06 Last edit: 2018-05-18 12:01:36	<input type="radio"/> Rockfall <input checked="" type="radio"/> Landslide	Hazard Type: Press (ctrl+click) to select more than one Diff. Erosion Translational Rotational Debris Flow
Road/Trail No: OYTS US22	Road/Trail: T <input type="text"/>	Road/Trail Class: Proposed	Rater: OG
Beginning Mile Marker: 0	Ending Mile Marker: 0	Side: NW - IF ROAD DIRE <input type="text"/>	Weather: A Few Clouds and B <input type="text"/>
Begin Coord. Lat/Long: Lat (##.#####): 45.25331 Long (-###.#####): -110.87161	End Coord. Lat/Long: Lat (##.#####): 45.25349 Long (-###.#####): -110.87145	Datum: WGS 84	AADT: 0
Length of Affected Road/T rail (ft): 54	Slope Height (rock)/Axial Length (slide) (ft): 150	Slope Angle (°): 37

Sight Distance (ft): 500	Usable Roadway/T rail Width (ft): 6	Speed Limit (mph): 2	
Ditch Width Range (ft): 0 - 0	Ditch Depth Range (ft): 0 - 0	Ditch Slope Range (H:V): 0:0 - 0:0	Block Size (ft): 0 Volume (cy): 0
Annual Rainfall Range (in): 10 - 20	Sole Access Route: No <input type="text"/>	Mitigation Present: NO <input type="text"/>	Photos/Documents(up to 10MB): <input type="button" value="Choose Files"/> No file chosen

Comments: Debris fan over trail ~2-3' debris current apex ~36' Slope distance from trail at about 26 degrees. Clasts up to 2-3' observed in fan. Point of Rocks section. [originally designated site US29]

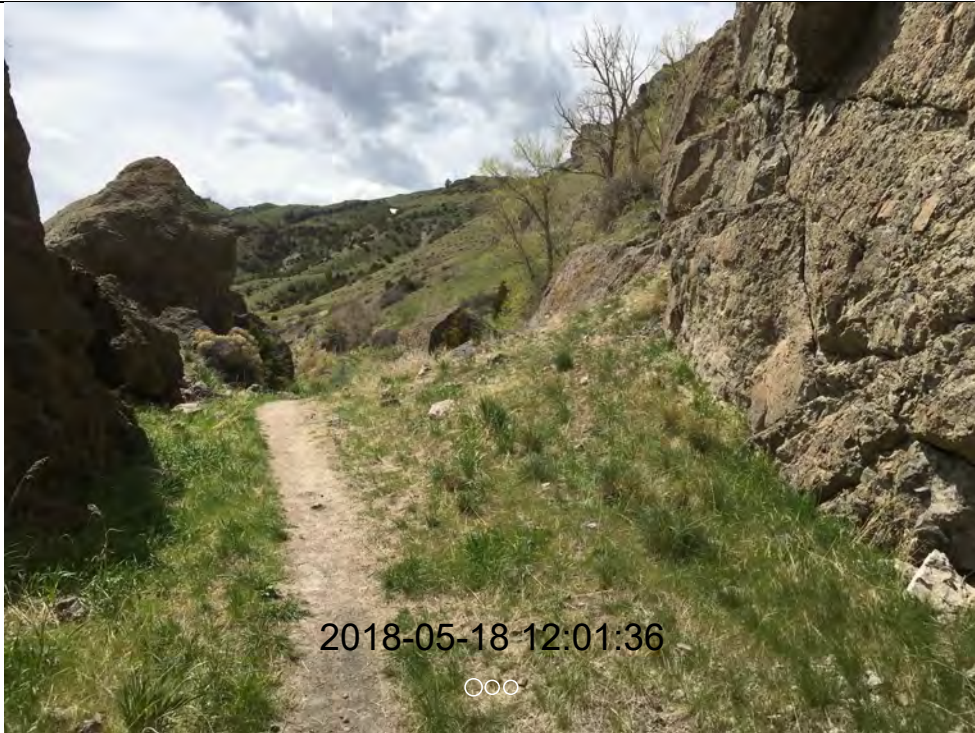
Slope Rating Form - Site Information (Rockfall)					
Management Area: OTHER <input type="text"/>		Date: 2018-06-07 14:25:35 Last edit: 2018-05-18 13:46:21		Hazard Type: Press (ctrl+click) to select more than one Raveling/Undermining Rock Avalanche Indeterminate Rock Failures Diff. Erosion	
Montana <input type="text"/>		<input checked="" type="radio"/> Rockfall <input type="radio"/> Landslide			
Park County <input type="text"/>					
Road/Trail No: OYTS US101	Road/Trail: R <input type="text"/>	Road/Trail Class: Proposed	Rater: OG		
Beginning Mile Marker: 0	Ending Mile Marker: 0	Side: NW - IF ROAD DIRE <input type="text"/>	Weather: Unknown <input type="text"/>		
Begin Coord. Lat/Long: Lat (###.#####): 45.16971 Long (-###.#####): -110.8649	End Coord. Lat/Long: Lat (###.#####): 45.17015 Long (-###.#####): -110.86613	Datum: WGS 84	AADT: 0		
Length of Affected Road/T rail (ft): 296	Slope Height (rock)/Axial Length (slide) (ft): 92	Slope Angle (°): 52

Sight Distance (ft): 171	Usable Roadway/T rail Width (ft): 12	Speed Limit (mph): 25			
Ditch Width Range (ft): 1 -2	Ditch Depth Range (ft): 0 -0	Ditch Slope Range (H:V): 0:0 -0:0	Block Size (ft): 2	Volume (cy): 0	
Annual Rainfall Range (in): 10 -20	Sole Access Route: No <input type="text"/>	Mitigation Present: NO <input type="text"/>	Photos/Documents(up to 10MB): <input type="button" value="Choose Files"/> No file chosen		
Comments: On road below yankee Jim toll rd 1. Differential erosion rockfall slope with zones of high and no veg. Rock king outside edge of road up to 2.5' on avg smaller in ditch. Yankee Jim Toll Road 1 section. [originally designated site US30 rd]					
Alternate database Name:			Alternate database ID:		
<input type="text"/>			<input type="text"/>		
Alternate database Description:					
<input type="text"/>					
Preliminary Ratings					
Category Rating:	3	9	27	81	Score:

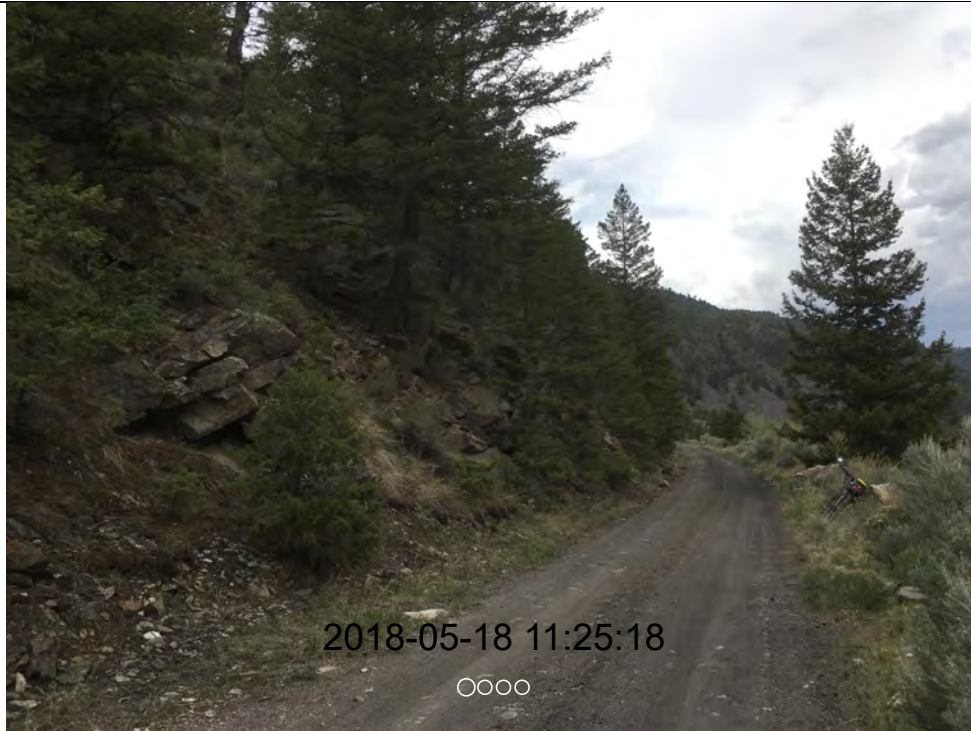
Slope Rating Form - Site Information (Rockfall)					
Management Area: OTHER <input type="text"/>		Date: 2018-06-07 13:59:00 Last edit: 2018-05-18 13:53:37		Hazard Type: Press (ctrl+click) to select more than one Raveling/Undermining Rock Avalanche Indeterminate Rock Failures Diff. Erosion	
Montana <input type="text"/> Park County <input type="text"/>		<input checked="" type="radio"/> Rockfall <input type="radio"/> Landslide			
Road/Trail No: OYTS US103	Road/Trail: R <input type="text"/>	Road/Trail Class: Proposed	Rater: OG NJ		
Beginning Mile Marker: 0	Ending Mile Marker: 0	Side: SE - IF ROAD DIRE <input type="text"/>	Weather: Partly Cloudy and Br <input type="text"/>		
Begin Coord. Lat/Long: Lat (##.#####): 45.17617 Long (-###.#####): -110.88262	End Coord. Lat/Long: Lat (##.#####): 45.17635 Long (-###.#####): -110.88296	Datum: WGS 84	AADT: 0		
Length of Affected Road/T rail (ft): 440	Slope Height (rock)/Axial Length (slide) (ft): 65		Slope Angle (°): 70

Sight Distance (ft): 350	Usable Roadway/T rail Width (ft): 12		Speed Limit (mph): 25		
Ditch Width Range (ft): 1 - 2	Ditch Depth Range (ft): 0 - 0	Ditch Slope Range (H:V): 0:0 - 0:0	Block Size (ft): 4 Volume (cy): 15		
Annual Rainfall Range (in): 10 - 20	Sole Access Route: No <input type="text"/>	Mitigation Present: NO <input type="text"/>	Photos/Documents(up to 10MB): <input type="button" value="Choose Files"/> No file chosen		
Comments: US02, large wedge features contributing bulk of material, large zones of weak biotite in gneiss. Yankee Jim Toll Road 2 section. [originally designated site US02]					
Alternate database Name:			Alternate database ID:		
Alternate database Description:					
Preliminary Ratings					
Category Rating:	3	9	27	81	Score:

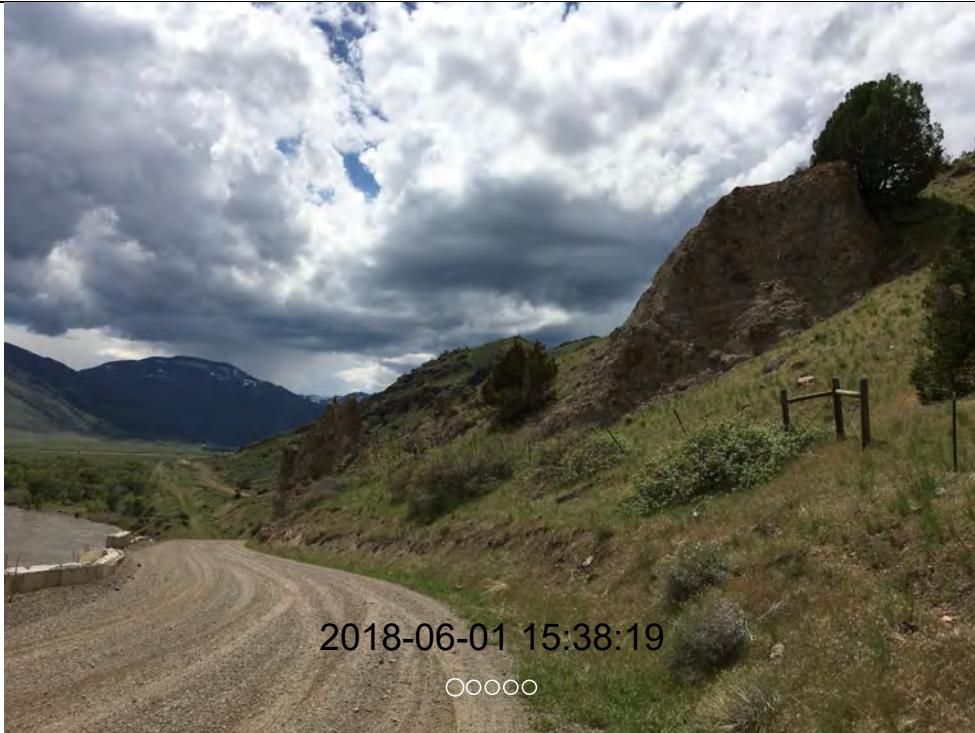
Slope Rating Form - Site Information (Rockfall)					
Management Area: OTHER <input type="text"/>		Date: 2018-06-04 15:32:55 Last edit: 2018-06-01 15:45:39		Hazard Type: Press (ctrl+click) to select more than one Planar <input type="checkbox"/> Wedge <input type="checkbox"/> Toppling <input type="checkbox"/> Raveling/Undermining <input type="checkbox"/>	
Montana <input type="text"/> Park County <input type="text"/>		<input checked="" type="radio"/> Rockfall <input type="radio"/> Landslide			
Road/Trail No: Oyst rd US111	Road/Trail: R <input type="text"/>	Road/Trail Class: County unpaved	Rater: OG		
Beginning Mile Marker: 0	Ending Mile Marker: 0	Side: W - IF ROAD DIREC <input type="text"/>	Weather: Unknown <input type="text"/>		
Begin Coord. Lat/Long: Lat (###.#####): 45.25325 Long (-###.#####): -110.87311	End Coord. Lat/Long: Lat (###.#####): 45.25402 Long (-###.#####): -110.8725	Datum: WGS 84	AADT: 0

Length of Affected Road/T rail (ft): 207	Slope Height (rock)/Axial Length (slide) (ft): 23	Slope Angle (°): 43			
Sight Distance (ft): 75	Usable Roadway/T rail Width (ft): 26	Speed Limit (mph): 35			
Ditch Width Range (ft): 0 - 0	Ditch Depth Range (ft): 0 - 0	Ditch Slope Range (H:V): 0:0 - 0:0	Block Size (ft): 0.5	Volume (cy): 0	
Annual Rainfall Range (in): 10 - 20	Sole Access Route: No <input type="text"/>	Mitigation Present: NO <input type="text"/>	Photos/Documents(up to 10MB): <input type="button" value="Choose Files"/> No file chosen		
Comments: <input type="text" value="Soil Cut with rock outcrop, discontinuously fx, glacial outwash seeds likely stratified Sand with gravel and cobble up to 1' observed, oversteepened brow. previously named US33"/>					
Alternate database Name:			Alternate database ID:		
<input type="text"/>			<input type="text"/>		
Alternate database Description:					
<input type="text"/>
